# Access Compliance Report

## Public Rights-of-Way

### (Curb Ramps)

Intersection ID: 30020	Main Street: SOLANO_DR	Cross Street: BERKELEY_PLACE_DR	Location: NW
ADA ID: 314AAACE818F8	Ramp Type: PerpDiag	Initial Pass/Fail: Fail	Overall Compliance: No
		Severity Score: 50

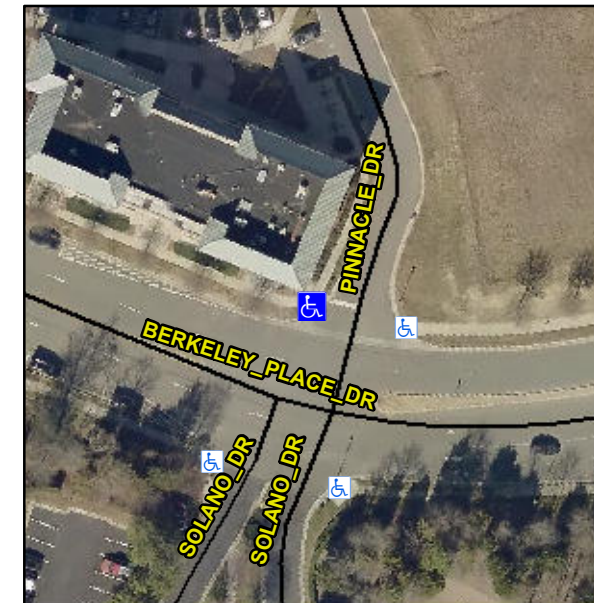
**R304.2.2, R304.5.3**

Compliance	Description	Data	Compliance	Description	Data
N/A	Ramp Length (in)	51.5	No	Ramp Slope (%)	12.4
Yes	Ramp Width (in)	70.5	No	Ramp XSlope (%)	7.6
N/A	Flare Type LT	N/A	N/A	Flare Type RT	N/A
N/A	Flare Slope LT (%)	N/A	N/A	Flare Slope RT (%)	N/A
N/A	Flare Traversable LT?	N/A	N/A	Flare Traversable RT?	N/A
N/A	Landing Length (in)	N/A	N/A	DWS Provided?	N/A
N/A	Landing Width (in)	N/A	N/A	DWS Contrast?	N/A
N/A	Landing Slope (%)	N/A	N/A	DWS Length (in)	N/A
N/A	Landing X Slope (%)	N/A	N/A	DWS Full Width?	N/A
N/A	Landing Curb? (Y/N)	N/A	N/A	DWS Offset (in)	N/A
N/A	Shared Landing?	N/A			
N/A	Gutter Ponding?	N/A	N/A	Gutter Slope (%)	N/A
N/A	Gutter Lip Ht (in)	N/A	N/A	Gutter X Slope (%)	N/A
N/A	Painted X Walk1?	No	N/A	Painted X Walk2?	No
	X Walk 1 Direction	To S		X Walk 2 Direction	To E
N/A	X Walk 1 Width (in)	N/A	N/A	X Walk 2 Width (in)	N/A
	X Walk 1 Slope (%)	0.3		X Walk 2 Slope (%)	2.8
	X Walk 1 X Slope (%)	3.2		X Walk 2 X Slope (%)	0.3

N/A	Ramp inside XWalk1?	N/A	N/A	Ramp inside XWalk2?	N/A
	Road Slope (%)	2.1	N/A	Clear Space?	N/A
	Road X Slope (%)	1.5	N/A	Clear Space to XWalk (in)	N/A
N/A	Any Obstructions?	N/A	N/A	Storm Grate/Utility Hazard?	N/A
	Obstruction Type			Storm Grate/Utility Type	
		N/A			N/A
			Yes	Surface Condition? (G/P)	Good

**Remove & Replace Curb Ramp With Two New Directional Ramps or Equivalent.**
