# Access Compliance Report

## Public Rights-of-Way

### (Curb Ramps)

Intersection ID: 4945	Main Street: LAWNMEADOW_DR	Cross Street: REAMES_RD	Location: SW
ADA ID: 314CB6F70485	Ramp Type: PerpDiag	Initial Pass/Fail: Fail	Overall Compliance: No
			Severity Score: 46.25

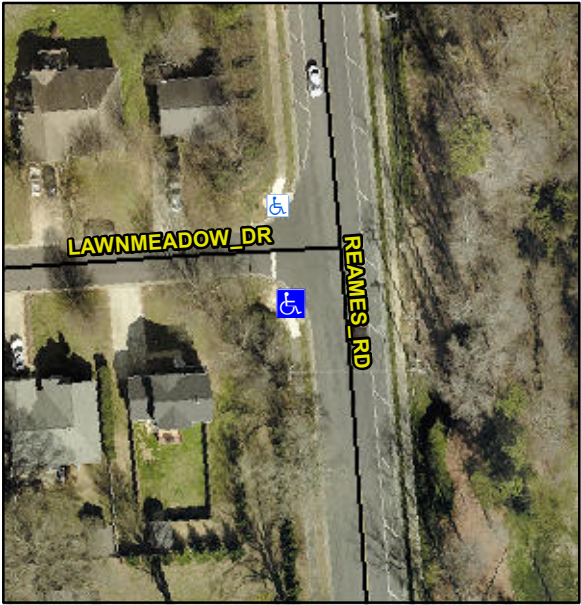
Compliance	Description	Data	Compliance	Description	Data
N/A	Ramp Length (in)	49.5	No	Ramp Slope (%)	8.6
No	Ramp Width (in)	41.0	No	Ramp XSlope (%)	9.8
N/A	Flare Type LT	N/A	N/A	Flare Type RT	N/A
N/A	Flare Slope LT (%)	N/A	N/A	Flare Slope RT (%)	N/A
N/A	Flare Traversable LT?	N/A	N/A	Flare Traversable RT?	N/A
N/A	Landing Length (in)	N/A	N/A	DWS Provided?	N/A
N/A	Landing Width (in)	N/A	N/A	DWS Contrast?	N/A
N/A	Landing Slope (%)	N/A	N/A	DWS Length (in)	N/A
N/A	Landing X Slope (%)	N/A	N/A	DWS Full Width?	N/A
N/A	Landing Curb? (Y/N)	N/A	N/A	DWS Offset (in)	N/A
N/A	Shared Landing?	N/A			
N/A	Gutter Ponding?	N/A	N/A	Gutter Slope (%)	N/A
N/A	Gutter Lip Ht (in)	N/A	N/A	Gutter X Slope (%)	N/A
N/A	Painted X Walk1?	No	N/A	Painted X Walk2?	No
	X Walk 1 Direction	To E		X Walk 2 Direction	To N
N/A	X Walk 1 Width (in)	N/A	N/A	X Walk 2 Width (in)	N/A
	X Walk 1 Slope (%)	4.0		X Walk 2 Slope (%)	4.2
	X Walk 1 X Slope (%)	6.4		X Walk 2 X Slope (%)	3.6

N/A	Ramp inside XWalk1?	N/A	N/A	Ramp inside XWalk2?	N/A
	Road Slope (%)	7.0	N/A	Clear Space?	N/A
	Road X Slope (%)	0.8	N/A	Clear Space to XWalk (in)	N/A
N/A	Any Obstructions?	N/A	N/A	Storm Grate/Utility Hazard?	N/A
	Obstruction Type			Storm Grate/Utility Type	
		N/A			N/A
			Yes	Surface Condition? (G/P)	Good

Possible Solutions:				
	<b>Remove &amp; Replace Curb Ramp With Two New Directional Ramps or Equivalent.</b>				
	Surveyor Notes:				
	<b>N/A</b>				
	PROW/ADA:				
	<b>Not Found, R304.5.1, R304.2.2, R304.5.3</b>				
Street 1 Name	REAMES RD				
Stop Condition-Street 2	None				
Street 2 Name	LAWNMEADOW DR				
Stop Condition-Street 1	StopSign				
Total Cost:		\$	3200.00
