Access Compliance Report

Public Rights-of-Way

(Curb Ramps)

Intersection ID: 16228	Main Street: RADCLIFFE_AV	Cross Street: STANFORD_PL	Location: SW
ADA ID: 315138D043B6	Ramp Type: Directional1	Initial Pass/Fail: Fail	Overall Compliance: No
Severity Score: 1.25			
Codes/Mitigation Info/Possible Solution		Field Measurements/Component Compliance

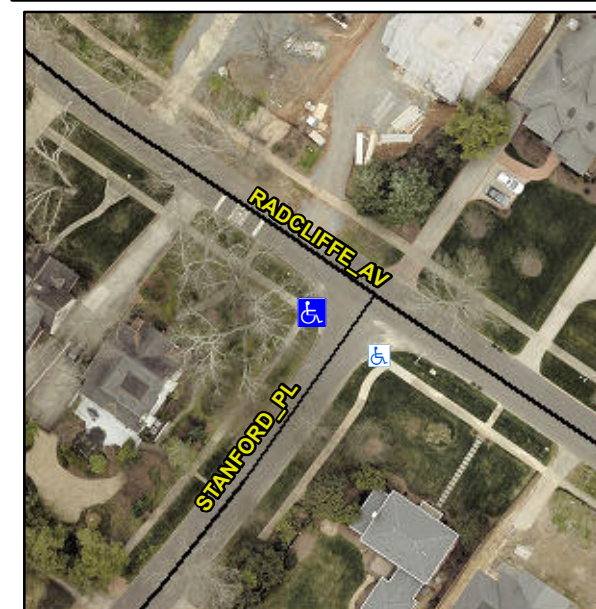
R304.5.3

Compliance	Description	Data	Compliance	Description	Data
N/A	Ramp Length (in)	40.5	N/A	Grade Break?	N/A
Yes	Ramp Width (in)	58.5	N/A	Grade Break Slope (%)	0.0
Yes	Ramp Slope (%)	3.4	N/A	Grade Break XSlope (%)	0.0
No	Ramp XSlope (%)	2.7			
N/A	Flare Type LT	N/A	N/A	Flare Type RT	N/A
N/A	Flare Slope LT (%)	N/A	N/A	Flare Slope RT (%)	0.0
N/A	Flare Traversable LT?	N/A	N/A	Flare Traversable RT?	N/A
N/A	Landing Length (in)	0.0	N/A	DWS Provided?	N/A
N/A	Landing Width (in)	0.0	N/A	DWS Contrast?	N/A
N/A	Landing Slope (%)	0.0	N/A	DWS Length (in)	N/A
N/A	Landing X Slope (%)	0.0	N/A	DWS Full Width?	N/A
N/A	Landing Curb? (Y/N)	N/A	N/A	DWS Offset LT (in)	N/A
N/A	Shared Landing?	N/A	N/A	DWS Offset RT (in)	N/A
N/A	Gutter Ponding?	0.0	N/A	Gutter Slope (%)	N/A
N/A	Gutter Lip Ht (in)	0.0	N/A	Gutter X Slope (%)	N/A
N/A	Painted X Walk1?	No		Road Slope (%)	3.8
	X Walk 1 Direction	To E		Road X Slope (%)	0.7
	X Walk 1 Width (in)	N/A		Clear Space?	N/A

X Walk 1 Slope (%)	3.8	N/A	Clear Space to XWalk (in)	N/A
	X Walk 1 X Slope (%)	0.7	N/A	Storm Grate/Utility Hazard?	N/A
N/A	Ramp inside XWalk1?	N/A		Storm Grate/Utility Type	
N/A	Any Obstructions?	N/A			N/A
	Obstruction Type		Yes	Surface Condition? (G/P)	Good
			N/A	Curb Slope (%)	8.8

Possible Solutions:

Remove & Replace Entire Ramp.
