Access Compliance Report

Public Rights-of-Way

(Curb Ramps)

Intersection ID: N/A	Main Street: MILLENNIUM_AV	Cross Street: POTOMAC_RIVER_PY	Location: SW
ADA ID: 3152A9634603	Ramp Type: Directional1	Initial Pass/Fail: Fail	Overall Compliance: No
Severity Score: 12.5			
Codes/Mitigation Info/Possible Solution		Field Measurements/Component Compliance

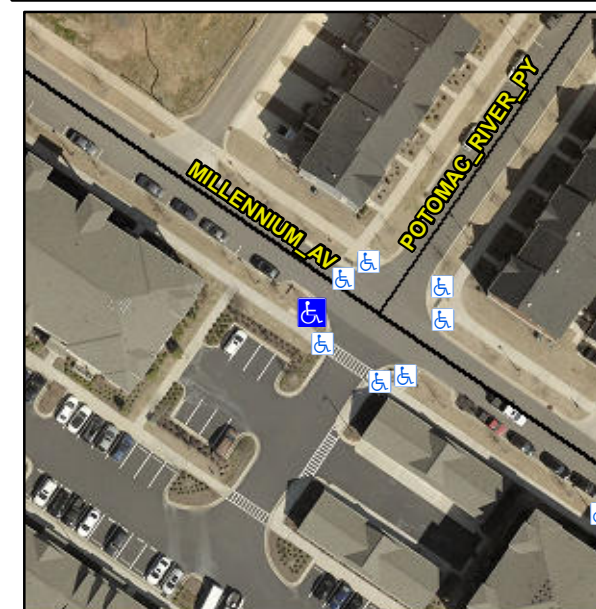
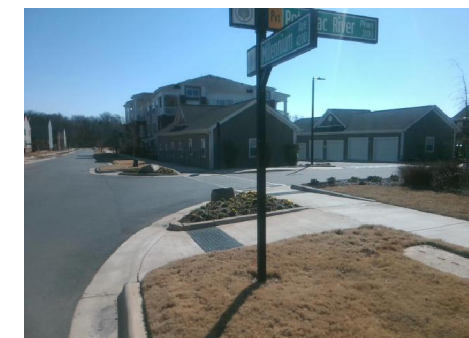
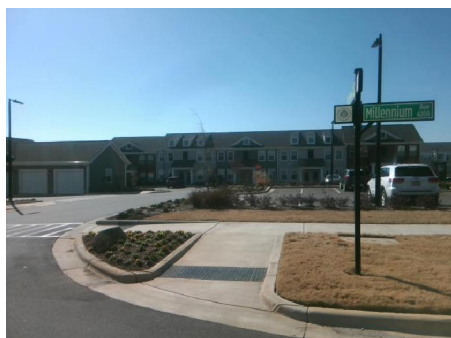
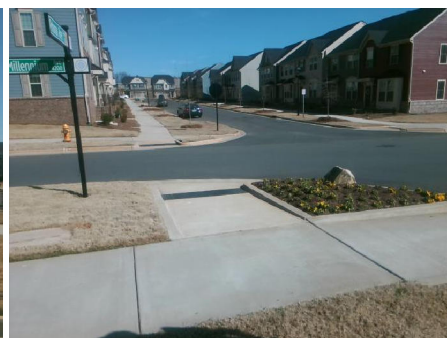
Compliance	Description	Data	Compliance	Description	Data
N/A	Ramp Length (in)	115.0	N/A	Grade Break?	N/A
Yes	Ramp Width (in)	70.0	N/A	Grade Break Slope (%)	0.0
No	Ramp Slope (%)	8.8	N/A	Grade Break XSlope (%)	0.0
Yes	Ramp XSlope (%)	1.6			
N/A	Flare Type LT	N/A	N/A	Flare Type RT	N/A
N/A	Flare Slope LT (%)	N/A	N/A	Flare Slope RT (%)	0.0
N/A	Flare Traversable LT?	N/A	N/A	Flare Traversable RT?	N/A
N/A	Landing Length (in)	0.0	N/A	DWS Provided?	N/A
N/A	Landing Width (in)	0.0	N/A	DWS Contrast?	N/A
N/A	Landing Slope (%)	0.0	N/A	DWS Length (in)	N/A
N/A	Landing X Slope (%)	0.0	N/A	DWS Full Width?	N/A
N/A	Landing Curb? (Y/N)	N/A	N/A	DWS Offset LT (in)	N/A
N/A	Shared Landing?	N/A	N/A	DWS Offset RT (in)	N/A
N/A	Gutter Ponding?	0.0	N/A	Gutter Slope (%)	N/A
N/A	Gutter Lip Ht (in)	0.0	N/A	Gutter X Slope (%)	N/A
N/A	Painted X Walk1?	No		Road Slope (%)	1.0
	X Walk 1 Direction	To NE		Road X Slope (%)	0.7
	X Walk 1 Width (in)	N/A		Clear Space?	N/A

X Walk 1 Slope (%)	1.0	N/A	Clear Space to XWalk (in)	N/A
	X Walk 1 X Slope (%)	0.7	N/A	Storm Grate/Utility Hazard?	N/A
N/A	Ramp inside XWalk1?	N/A		Storm Grate/Utility Type	
N/A	Any Obstructions?	N/A			N/A
	Obstruction Type		Yes	Surface Condition? (G/P)	Good
			N/A	Curb Slope (%)	7.4

Possible Solutions:

Remove & Replace Entire Ramp.

PROW/ADA:

R304.2.2
