Access Compliance Report

Public Rights-of-Way

(Curb Ramps)

Intersection ID: 28636	Main Street: CAMP_STEWART_RD	Cross Street: STEWARTS_CROSSING_DR	Location: SE
ADA ID: 3152FD6C940A	Ramp Type: Perp	Initial Pass/Fail: Fail	Overall Compliance: No
Severity Score: 46.25			
Codes/Mitigation Info/Possible Solution		Field Measurements/Component Compliance

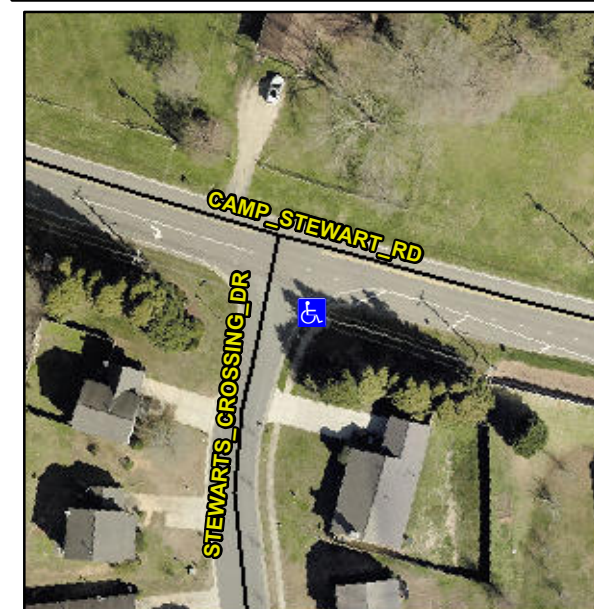
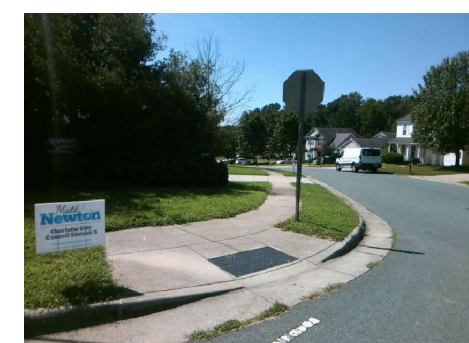
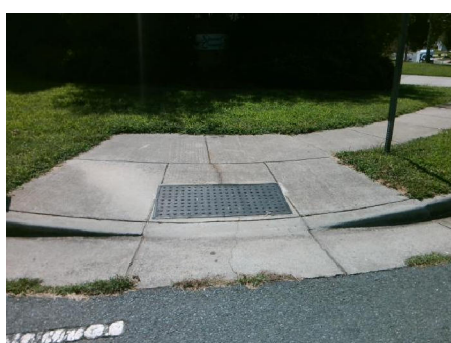
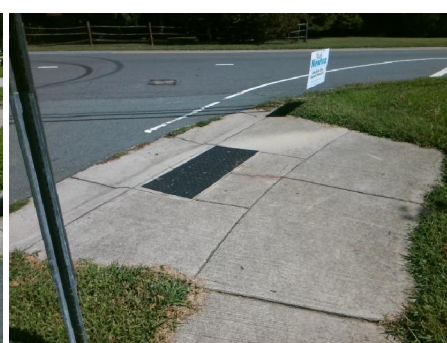
Not Found, R304.5.1, R304.2.2, R304.5.3

Compliance	Description	Data	Compliance	Description	Data
N/A	Ramp Length (in)	48.0	No	Ramp Slope (%)	10.9
No	Ramp Width (in)	43.5	No	Ramp XSlope (%)	7.2
N/A	Flare Type LT	N/A	N/A	Flare Type RT	N/A
N/A	Flare Slope LT (%)	N/A	N/A	Flare Slope RT (%)	N/A
N/A	Flare Traversable LT?	N/A	N/A	Flare Traversable RT?	N/A
N/A	Landing Length (in)	N/A	N/A	DWS Provided?	N/A
N/A	Landing Width (in)	N/A	N/A	DWS Contrast?	N/A
N/A	Landing Slope (%)	N/A	N/A	DWS Length (in)	N/A
N/A	Landing X Slope (%)	N/A	N/A	DWS Full Width?	N/A
N/A	Landing Curb? (Y/N)	N/A	N/A	DWS Offset (in)	N/A
N/A	Shared Landing?	N/A			
N/A	Gutter Ponding?	N/A	N/A	Gutter Slope (%)	N/A
N/A	Gutter Lip Ht (in)	N/A	N/A	Gutter X Slope (%)	N/A
N/A	Painted X Walk1?	No	N/A	Painted X Walk2?	N/A
	X Walk 1 Direction	To NW		X Walk 2 Direction	N/A
N/A	X Walk 1 Width (in)	N/A	N/A	X Walk 2 Width (in)	N/A
	X Walk 1 Slope (%)	2.6		X Walk 2 Slope (%)	N/A
	X Walk 1 X Slope (%)	4.5		X Walk 2 X Slope (%)	N/A

N/A	Ramp inside XWalk1?	N/A	N/A	Ramp inside XWalk2?	N/A
	Road Slope (%)	4.5	N/A	Clear Space?	N/A
	Road X Slope (%)	2.6	N/A	Clear Space to XWalk (in)	N/A
N/A	Any Obstructions?	N/A	N/A	Storm Grate/Utility Hazard?	N/A
	Obstruction Type			Storm Grate/Utility Type	
		N/A			N/A
			Yes	Surface Condition? (G/P)	Good

Possible Solutions:

Remove & Replace Entire Ramp.
