# Access Compliance Report

## Public Rights-of-Way

### (Curb Ramps)

Intersection ID: 52996	Main Street: TIMBERBROOK_DR	Cross Street: VICTORIA_BROOK_LN	Location: NE
ADA ID: 3154AAFB58B8	Ramp Type: PerpDiag	Initial Pass/Fail: Fail	Overall Compliance: No
Severity Score: 8.75			
Codes/Mitigation Info/Possible Solution		Field Measurements/Component Compliance

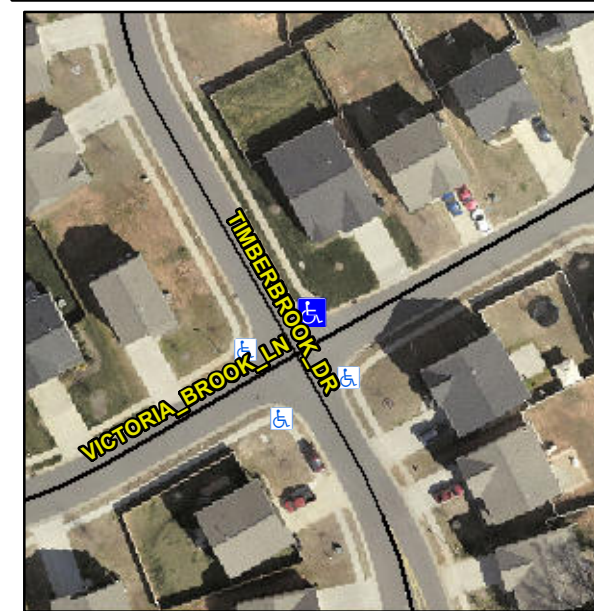
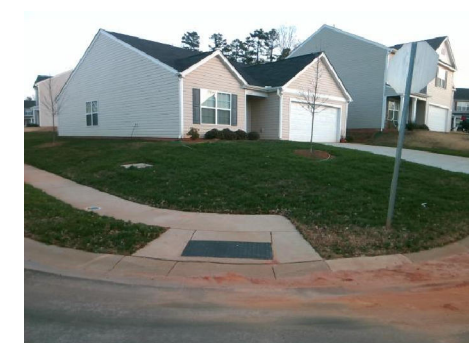
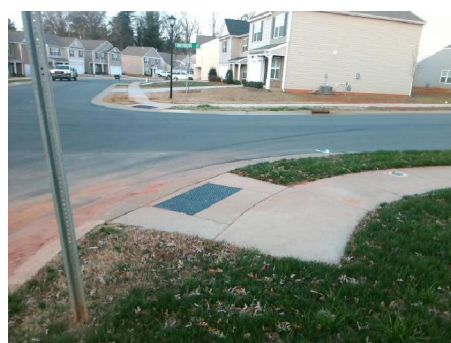
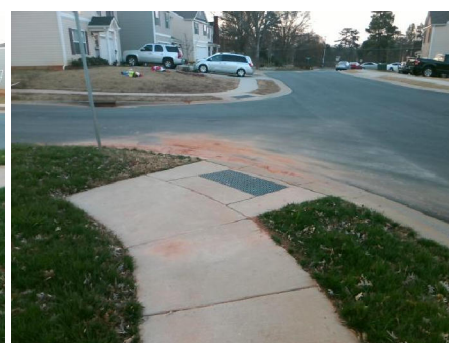
**Not Found, R304.5.1**

Compliance	Description	Data	Compliance	Description	Data
N/A	Ramp Length (in)	48.5	Yes	Ramp Slope (%)	6.6
No	Ramp Width (in)	47.0	Yes	Ramp XSlope (%)	1.7
N/A	Flare Type LT	N/A	N/A	Flare Type RT	N/A
N/A	Flare Slope LT (%)	N/A	N/A	Flare Slope RT (%)	N/A
N/A	Flare Traversable LT?	N/A	N/A	Flare Traversable RT?	N/A
N/A	Landing Length (in)	N/A	N/A	DWS Provided?	N/A
N/A	Landing Width (in)	N/A	N/A	DWS Contrast?	N/A
N/A	Landing Slope (%)	N/A	N/A	DWS Length (in)	N/A
N/A	Landing X Slope (%)	N/A	N/A	DWS Full Width?	N/A
N/A	Landing Curb? (Y/N)	N/A	N/A	DWS Offset (in)	N/A
N/A	Shared Landing?	N/A			
N/A	Gutter Ponding?	Yes	N/A	Gutter Slope (%)	N/A
N/A	Gutter Lip Ht (in)	N/A	N/A	Gutter X Slope (%)	N/A
N/A	Painted X Walk1?	No	N/A	Painted X Walk2?	No
	X Walk 1 Direction	To W		X Walk 2 Direction	To S
N/A	X Walk 1 Width (in)	N/A	N/A	X Walk 2 Width (in)	N/A
	X Walk 1 Slope (%)	1.4		X Walk 2 Slope (%)	1.7
	X Walk 1 X Slope (%)	0.9		X Walk 2 X Slope (%)	1.9

N/A	Ramp inside XWalk1?	N/A	N/A	Ramp inside XWalk2?	N/A
	Road Slope (%)	0.9	N/A	Clear Space?	N/A
	Road X Slope (%)	1.8	N/A	Clear Space to XWalk (in)	N/A
N/A	Any Obstructions?	N/A	N/A	Storm Grate/Utility Hazard?	N/A
	Obstruction Type			Storm Grate/Utility Type	
		N/A			N/A
		Yes		Surface Condition? (G/P)	Good

**Remove & Replace Curb Ramp With Two New Directional Ramps or Equivalent.**

Total Cost: \$ 3200.00
