Access Compliance Report

Public Rights-of-Way

(Curb Ramps)

Intersection ID: N/A	Main Street: SPEER_BV	Cross Street: MILLENNIUM_AV	Location: NE
ADA ID: 315C64242AA0	Ramp Type: Perp	Initial Pass/Fail: Fail	Overall Compliance: No
Severity Score: 21.25			
Codes/Mitigation Info/Possible Solution		Field Measurements/Component Compliance

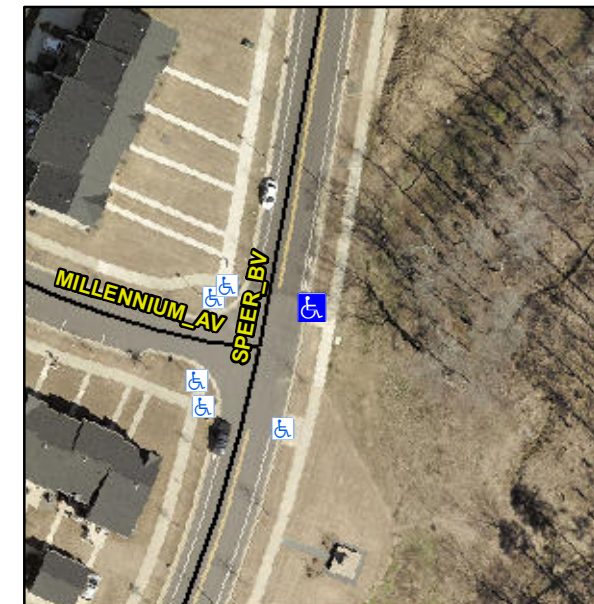
Compliance	Description	Data	Compliance	Description	Data
N/A	Ramp Length (in)	94.0	No	Ramp Slope (%)	10.5
No	Ramp Width (in)	46.5	Yes	Ramp XSlope (%)	0.1
N/A	Flare Type LT	N/A	N/A	Flare Type RT	N/A
N/A	Flare Slope LT (%)	N/A	N/A	Flare Slope RT (%)	N/A
N/A	Flare Traversable LT?	N/A	N/A	Flare Traversable RT?	N/A
N/A	Landing Length (in)	N/A	N/A	DWS Provided?	N/A
N/A	Landing Width (in)	N/A	N/A	DWS Contrast?	N/A
N/A	Landing Slope (%)	N/A	N/A	DWS Length (in)	N/A
N/A	Landing X Slope (%)	N/A	N/A	DWS Full Width?	N/A
N/A	Landing Curb? (Y/N)	N/A	N/A	DWS Offset (in)	N/A
N/A	Shared Landing?	N/A			
N/A	Gutter Ponding?	N/A	N/A	Gutter Slope (%)	N/A
N/A	Gutter Lip Ht (in)	N/A	N/A	Gutter X Slope (%)	N/A
N/A	Painted X Walk1?	No	N/A	Painted X Walk2?	N/A
	X Walk 1 Direction	To W		X Walk 2 Direction	N/A
N/A	X Walk 1 Width (in)	N/A	N/A	X Walk 2 Width (in)	N/A
	X Walk 1 Slope (%)	3.1		X Walk 2 Slope (%)	N/A
	X Walk 1 X Slope (%)	0.8		X Walk 2 X Slope (%)	N/A

N/A	Ramp inside XWalk1?	N/A	N/A	Ramp inside XWalk2?	N/A
	Road Slope (%)	N/A	N/A	Clear Space?	N/A
	Road X Slope (%)	N/A	N/A	Clear Space to XWalk (in)	N/A
N/A	Any Obstructions?	N/A	N/A	Storm Grate/Utility Hazard?	N/A
	Obstruction Type			Storm Grate/Utility Type	
		N/A			N/A
		Yes		Surface Condition? (G/P)	Good

Possible Solutions:

Remove & Replace Entire Ramp.

R304.5.1, R304.2.2
