# Access Compliance Report

## Public Rights-of-Way

### (Curb Ramps)

| Intersection ID: 17743 | Main Street: LORENE_AV | Cross Street: SELWYN_AV | Location: SE |

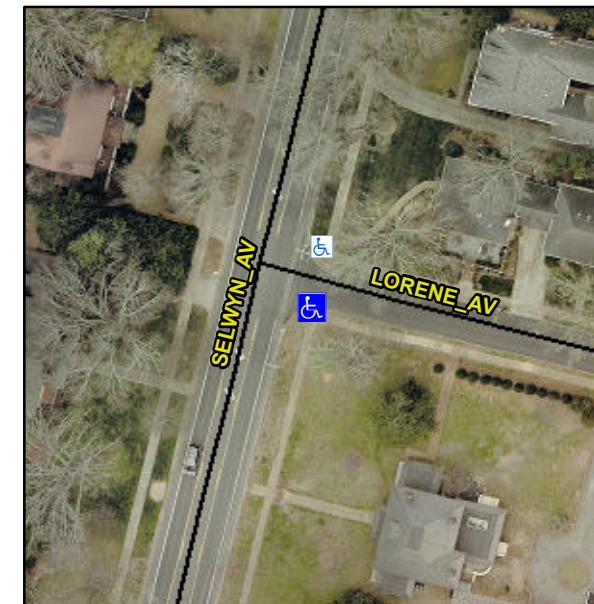
**NO CURB LINE**

**R304.5.1, R304.2.2, R304.5.3**

| Compliance | Description | Data | Compliance | Description | Data |
|---|---|---|---|---|---|
| No | Ramp Width (in) | 36.0 | N/A | Grade Break Slope (%) | 0.0 |
| No | Ramp Slope (%) | 13.9 | N/A | Grade Break XSlope (%) | 0.0 |
| No | Ramp XSlope (%) | 3.0 | | | |

**Remove & Replace Entire Ramp.**
