Access Compliance Report

Public Rights-of-Way

(Curb Ramps)

Intersection ID: 43650	Main Street: CAMDEN_MEADOW_DR	Cross Street: BALLINDERRY_DR	Location: SE
ADA ID: 316EF0802BE0	Ramp Type: Perp	Initial Pass/Fail: Fail	Overall Compliance: No
Codes/Mitigation Info/Possible Solution		Field Measurements/Component Compliance	
Severity Score: 26.25

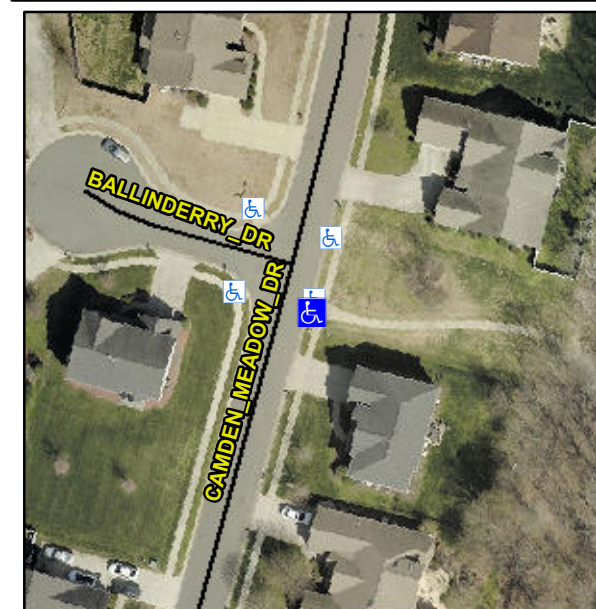
Not Found, R304.2.2, R304.5.3

Compliance	Description	Data	Compliance	Description	Data
N/A	Ramp Length (in)	47.0	No	Ramp Slope (%)	12.3
Yes	Ramp Width (in)	49.5	No	Ramp XSlope (%)	2.3
N/A	Flare Type LT	N/A	N/A	Flare Type RT	N/A
N/A	Flare Slope LT (%)	N/A	N/A	Flare Slope RT (%)	N/A
N/A	Flare Traversable LT?	N/A	N/A	Flare Traversable RT?	N/A
N/A	Landing Length (in)	N/A	N/A	DWS Provided?	N/A
N/A	Landing Width (in)	N/A	N/A	DWS Contrast?	N/A
N/A	Landing Slope (%)	N/A	N/A	DWS Length (in)	N/A
N/A	Landing X Slope (%)	N/A	N/A	DWS Full Width?	N/A
N/A	Landing Curb? (Y/N)	N/A	N/A	DWS Offset (in)	N/A
N/A	Shared Landing?	N/A			
N/A	Gutter Ponding?	N/A	N/A	Gutter Slope (%)	N/A
N/A	Gutter Lip Ht (in)	N/A	N/A	Gutter X Slope (%)	N/A
N/A	Painted X Walk1?	No	N/A	Painted X Walk2?	N/A
	X Walk 1 Direction	To W		X Walk 2 Direction	N/A
N/A	X Walk 1 Width (in)	N/A	N/A	X Walk 2 Width (in)	N/A
	X Walk 1 Slope (%)	5.3		X Walk 2 Slope (%)	N/A
	X Walk 1 X Slope (%)	1.5		X Walk 2 X Slope (%)	N/A

Remove & Replace Entire Ramp.
