Access Compliance Report

Public Rights-of-Way

(Curb Ramps)

Intersection ID: 21411	Main Street: MONROE_RD	Cross Street: SARDIS_RD_NORTH	Location: NE
ADA ID: 3173CE6D9556	Ramp Type: Para	Initial Pass/Fail: Fail	Overall Compliance: No
			Severity Score: 13.75

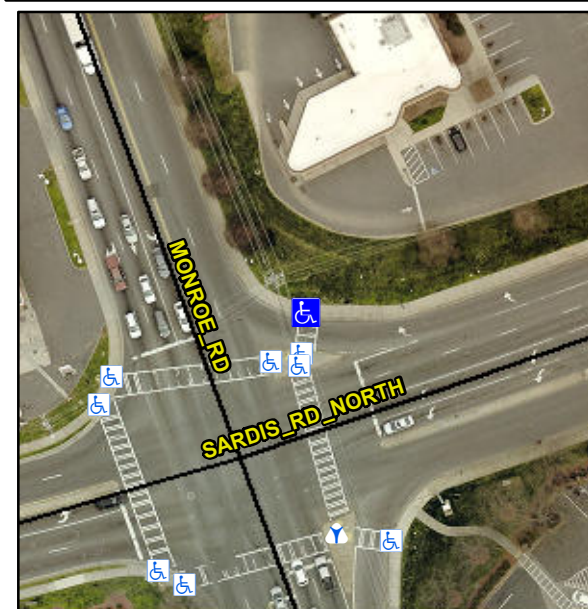
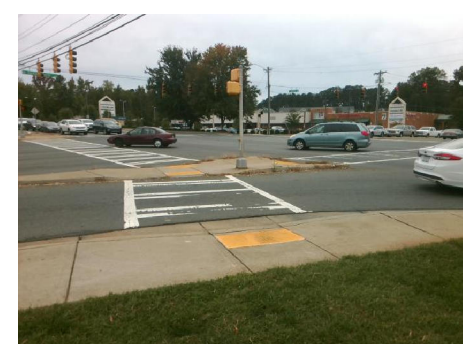
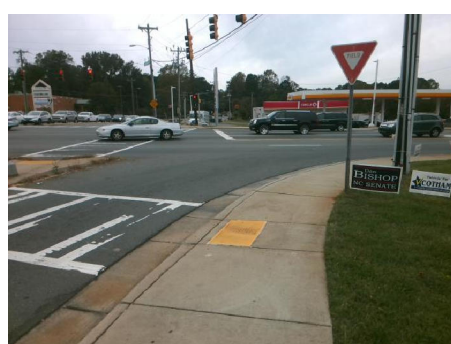
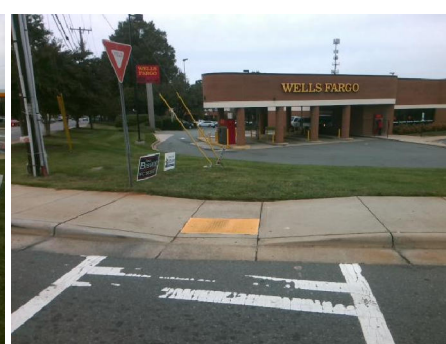
Compliance	Description	Data	Compliance	Description	Data
N/A	Ramp Length LT (in)	64.0	N/A	Ramp Length RT (in)	70.0
Yes	Ramp Width LT (in)	78.0	Yes	Ramp Width RT (in)	71.0
No	Ramp Slope LT (%)	9.4	Yes	Ramp Slope RT (%)	6.1
No	Ramp XSlope LT (%)	2.2	Yes	Ramp XSlope RT (%)	0.7
N/A	Landing Length (in)	N/A	N/A	DWS Provided?	N/A
N/A	Landing Width (in)	N/A	N/A	DWS Contrast?	N/A
N/A	Landing Slope (%)	N/A	N/A	DWS Length (in)	N/A
N/A	Landing X Slope (%)	N/A	N/A	DWS Full Width?	N/A
N/A	Landing Curb? (Y/N)	N/A	N/A	DWS Offset (in)	N/A
N/A	Shared Landing?	N/A			
N/A	Gutter Ponding?	N/A	N/A	Gutter Slope (%)	N/A
N/A	Gutter Lip Ht (in)	N/A	N/A	Gutter X Slope (%)	N/A
N/A	Painted X Walk1?	Yes	N/A	Painted X Walk2?	N/A
	X Walk 1 Direction	To SW		X Walk 2 Direction	N/A
N/A	X Walk 1 Width (in)	113.0	N/A	X Walk 2 Width (in)	N/A
	X Walk 1 Slope (%)	4.1		X Walk 2 Slope (%)	N/A
	X Walk 1 X Slope (%)	0.3		X Walk 2 X Slope (%)	N/A
N/A	Ramp inside XWalk1?	Yes	N/A	Ramp inside XWalk2?	N/A

Road Slope (%)	N/A	N/A	Clear Space?	N/A
	Road X Slope (%)	N/A	N/A	Clear Space to XWalk (in)	N/A
N/A	Any Obstructions?	N/A	N/A	Storm Grate/Utility Hazard?	N/A
	Obstruction Type			Storm Grate/Utility Type	
		N/A			N/A
			Yes	Surface Condition? (G/P)	Good
			N/A	Curb Slope (%)	5.8

Possible Solutions:

Remove & Replace Entire Ramp.
