# Access Compliance Report

## Public Rights-of-Way

### (Curb Ramps)

Intersection ID: 44204	Main Street: MOCKERNUT_DR	Cross Street: COFFEE_TREE_CT	Location: SE
ADA ID: 317535635702	Ramp Type: PerpDiag	Initial Pass/Fail: Fail	Overall Compliance: No
Severity Score: 33.75			
Codes/Mitigation Info/Possible Solution		Field Measurements/Component Compliance

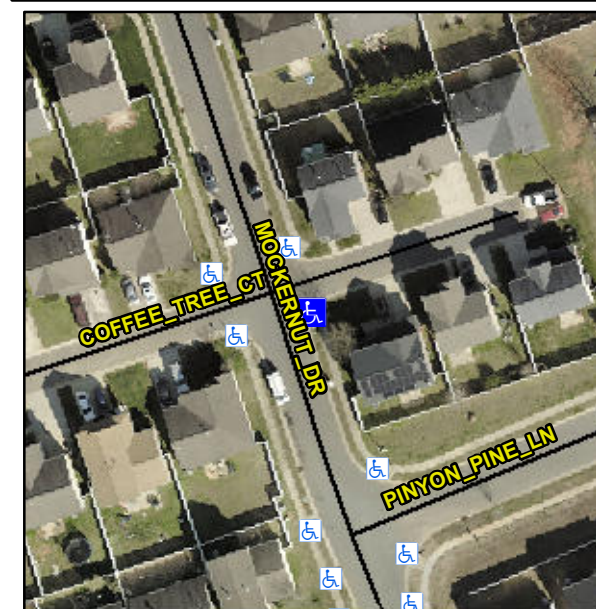
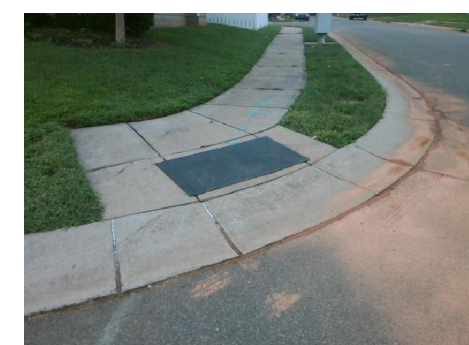
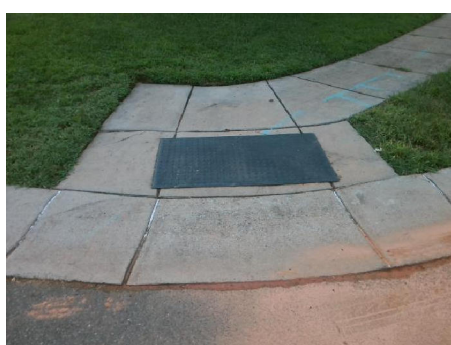
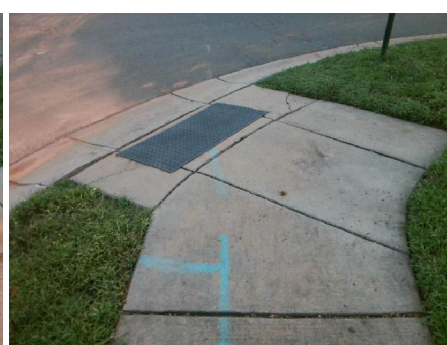
**Not Found, R304.5.1, R304.2.2**

Compliance	Description	Data	Compliance	Description	Data
N/A	Ramp Length (in)	33.5	No	Ramp Slope (%)	12.6
No	Ramp Width (in)	39.5	Yes	Ramp XSlope (%)	0.7
N/A	Flare Type LT	N/A	N/A	Flare Type RT	N/A
N/A	Flare Slope LT (%)	N/A	N/A	Flare Slope RT (%)	N/A
N/A	Flare Traversable LT?	N/A	N/A	Flare Traversable RT?	N/A
N/A	Landing Length (in)	N/A	N/A	DWS Provided?	N/A
N/A	Landing Width (in)	N/A	N/A	DWS Contrast?	N/A
N/A	Landing Slope (%)	N/A	N/A	DWS Length (in)	N/A
N/A	Landing X Slope (%)	N/A	N/A	DWS Full Width?	N/A
N/A	Landing Curb? (Y/N)	N/A	N/A	DWS Offset (in)	N/A
N/A	Shared Landing?	N/A			
N/A	Gutter Ponding?	N/A	N/A	Gutter Slope (%)	N/A
N/A	Gutter Lip Ht (in)	N/A	N/A	Gutter X Slope (%)	N/A
N/A	Painted X Walk1?	No	N/A	Painted X Walk2?	No
	X Walk 1 Direction	To N		X Walk 2 Direction	To W
N/A	X Walk 1 Width (in)	N/A	N/A	X Walk 2 Width (in)	N/A
	X Walk 1 Slope (%)	2.7		X Walk 2 Slope (%)	1.8
	X Walk 1 X Slope (%)	0.6		X Walk 2 X Slope (%)	4.5

N/A	Ramp inside XWalk1?	N/A	N/A	Ramp inside XWalk2?	N/A
	Road Slope (%)	2.1	N/A	Clear Space?	N/A
	Road X Slope (%)	2.7	N/A	Clear Space to XWalk (in)	N/A
N/A	Any Obstructions?	N/A	N/A	Storm Grate/Utility Hazard?	N/A
	Obstruction Type			Storm Grate/Utility Type	
		N/A			N/A
		Yes		Surface Condition? (G/P)	Good

**Remove & Replace Curb Ramp With Two New Directional Ramps or Equivalent.**

Total Cost: \$ 3200.00
