Access Compliance Report

Public Rights-of-Way

(Curb Ramps)

Intersection ID: 20503	Main Street: EMERALD_MEADOW_LN	Cross Street: MORNING_MIST_LN	Location: W
ADA ID: 317A66F68A6D	Ramp Type: PerpDiag	Initial Pass/Fail: Fail	Overall Compliance: No
Severity Score: 25			
Codes/Mitigation Info/Possible Solution		Field Measurements/Component Compliance

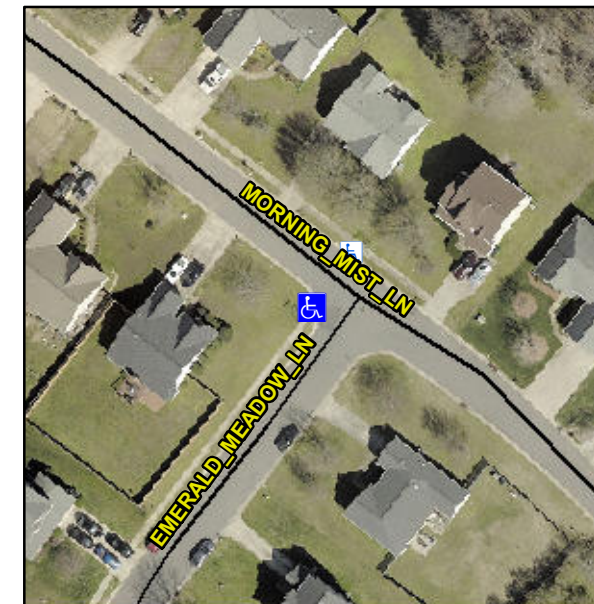
Not Found, R304.2.2, R304.5.3

Compliance	Description	Data	Compliance	Description	Data
N/A	Ramp Length (in)	47.0	No	Ramp Slope (%)	9.1
Yes	Ramp Width (in)	48.0	No	Ramp XSlope (%)	5.9
N/A	Flare Type LT	N/A	N/A	Flare Type RT	N/A
N/A	Flare Slope LT (%)	N/A	N/A	Flare Slope RT (%)	N/A
N/A	Flare Traversable LT?	N/A	N/A	Flare Traversable RT?	N/A
N/A	Landing Length (in)	N/A	N/A	DWS Provided?	N/A
N/A	Landing Width (in)	N/A	N/A	DWS Contrast?	N/A
N/A	Landing Slope (%)	N/A	N/A	DWS Length (in)	N/A
N/A	Landing X Slope (%)	N/A	N/A	DWS Full Width?	N/A
N/A	Landing Curb? (Y/N)	N/A	N/A	DWS Offset (in)	N/A
N/A	Shared Landing?	N/A			
N/A	Gutter Ponding?	N/A	N/A	Gutter Slope (%)	N/A
N/A	Gutter Lip Ht (in)	N/A	N/A	Gutter X Slope (%)	N/A
N/A	Painted X Walk1?	No	N/A	Painted X Walk2?	No
	X Walk 1 Direction	To SE		X Walk 2 Direction	To NE
N/A	X Walk 1 Width (in)	N/A	N/A	X Walk 2 Width (in)	N/A
	X Walk 1 Slope (%)	0.4		X Walk 2 Slope (%)	5.1
	X Walk 1 X Slope (%)	4.9		X Walk 2 X Slope (%)	1.8

N/A	Ramp inside XWalk1?	N/A	N/A	Ramp inside XWalk2?	N/A
	Road Slope (%)	2.3	N/A	Clear Space?	N/A
	Road X Slope (%)	5.6	N/A	Clear Space to XWalk (in)	N/A
N/A	Any Obstructions?	N/A	N/A	Storm Grate/Utility Hazard?	N/A
	Obstruction Type			Storm Grate/Utility Type	
		N/A			N/A
			Yes	Surface Condition? (G/P)	Good

Remove & Replace Curb Ramp With Two New Directional Ramps or Equivalent.

Total Cost: \$ 3200.00
