# Access Compliance Report

## Public Rights-of-Way

### (Curb Ramps)

Intersection ID: 10031127	Main Street: MARGARET_WALLACE_RD	Cross Street: N/A	Location: NE
ADA ID: 317CF3FFE80E	Ramp Type: PerpDiag	Initial Pass/Fail: Fail	Overall Compliance: No
Severity Score: 60			
Codes/Mitigation Info/Possible Solution		Field Measurements/Component Compliance

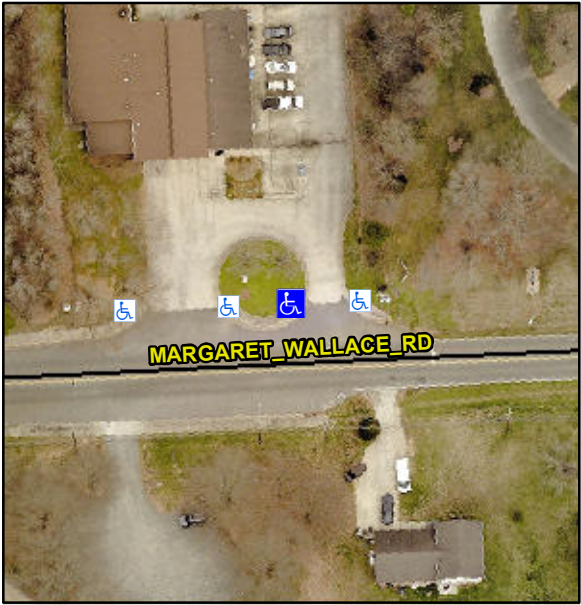
Possible Solutions:	Compliance	Description	Data	Compliance	Description	Data
	Remove & Replace Curb Ramp With Two New Directional Ramps or Equivalent.	N/A	Ramp Length (in)	62.0	No	Ramp Slope (%)	8.9
		No	Ramp Width (in)	24.0	No	Ramp XSlope (%)	5.9
		N/A	Flare Type LT	N/A	N/A	Flare Type RT	N/A
		N/A	Flare Slope LT (%)	N/A	N/A	Flare Slope RT (%)	N/A
		N/A	Flare Traversable LT?	N/A	N/A	Flare Traversable RT?	N/A
		N/A	Landing Length (in)	N/A	N/A	DWS Provided?	N/A
		N/A	Landing Width (in)	N/A	N/A	DWS Contrast?	N/A
		N/A	Landing Slope (%)	N/A	N/A	DWS Length (in)	N/A
		N/A	Landing X Slope (%)	N/A	N/A	DWS Full Width?	N/A
		N/A	Landing Curb? (Y/N)	N/A	N/A	DWS Offset (in)	N/A
		N/A	Shared Landing?	N/A			
		N/A	Gutter Ponding?	N/A	N/A	Gutter Slope (%)	N/A
		N/A	Gutter Lip Ht (in)	N/A	N/A	Gutter X Slope (%)	N/A
		N/A	Painted X Walk1?	No	N/A	Painted X Walk2?	No
			X Walk 1 Direction	To S		X Walk 2 Direction	To W
		N/A	X Walk 1 Width (in)	N/A	N/A	X Walk 2 Width (in)	N/A

X Walk 1 Slope (%)	3.1		X Walk 2 Slope (%)	3.4
			X Walk 1 X Slope (%)	3.5		X Walk 2 X Slope (%)	2.0
		N/A	Ramp inside XWalk1?	N/A	N/A	Ramp inside XWalk2?	N/A
<p>Surveyor Notes:</p> <p>N/A</p>			Road Slope (%)	3.7	N/A	Clear Space?	N/A
			Road X Slope (%)	0.0	N/A	Clear Space to XWalk (in)	N/A
<p>PROW/ADA:</p> <p>Not Found, R304.5.1, R304.2.2, R304.5.3</p>		N/A	Any Obstructions?	N/A	N/A	Storm Grate/Utility Hazard?	N/A
			Obstruction Type			Storm Grate/Utility Type	
Total Cost:			\$	3200.00	N/A		N/A
					Yes	Surface Condition? (G/P)	Good
