Access Compliance Report

Public Rights-of-Way

(Curb Ramps)

Intersection ID: 52927	Main Street: EMORY_OAK_DR	Cross Street: GRAY_OAK_LN	Location: S
ADA ID: 31802F76F5A0	Ramp Type: Perp	Initial Pass/Fail: Fail	Overall Compliance: No
Severity Score: 8.75			
Codes/Mitigation Info/Possible Solution		Field Measurements/Component Compliance

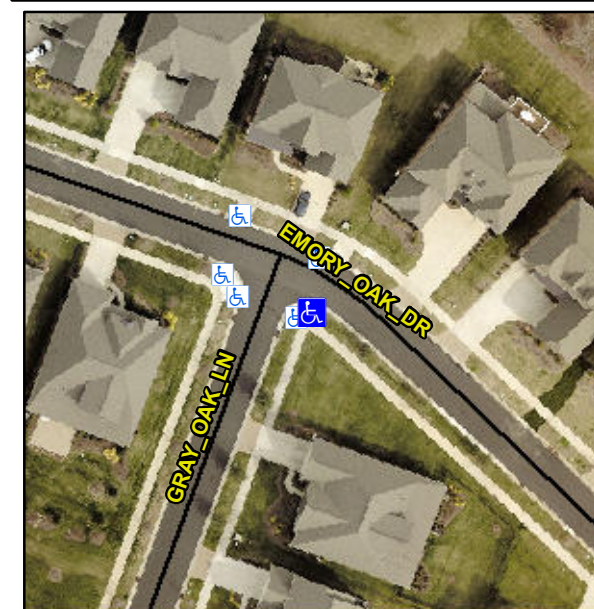
Not Found, R304.5.1

Compliance	Description	Data	Compliance	Description	Data
N/A	Ramp Length (in)	73.0	Yes	Ramp Slope (%)	5.3
No	Ramp Width (in)	37.0	Yes	Ramp XSlope (%)	0.8
N/A	Flare Type LT	N/A	N/A	Flare Type RT	N/A
N/A	Flare Slope LT (%)	N/A	N/A	Flare Slope RT (%)	N/A
N/A	Flare Traversable LT?	N/A	N/A	Flare Traversable RT?	N/A
N/A	Landing Length (in)	N/A	N/A	DWS Provided?	N/A
N/A	Landing Width (in)	N/A	N/A	DWS Contrast?	N/A
N/A	Landing Slope (%)	N/A	N/A	DWS Length (in)	N/A
N/A	Landing X Slope (%)	N/A	N/A	DWS Full Width?	N/A
N/A	Landing Curb? (Y/N)	N/A	N/A	DWS Offset (in)	N/A
N/A	Shared Landing?	N/A			
N/A	Gutter Ponding?	N/A	N/A	Gutter Slope (%)	N/A
N/A	Gutter Lip Ht (in)	N/A	N/A	Gutter X Slope (%)	N/A
N/A	Painted X Walk1?	No	N/A	Painted X Walk2?	N/A
	X Walk 1 Direction	To N		X Walk 2 Direction	N/A
N/A	X Walk 1 Width (in)	N/A	N/A	X Walk 2 Width (in)	N/A
	X Walk 1 Slope (%)	4.5		X Walk 2 Slope (%)	N/A
	X Walk 1 X Slope (%)	3.1		X Walk 2 X Slope (%)	N/A

N/A	Ramp inside XWalk1?	N/A	N/A	Ramp inside XWalk2?	N/A
	Road Slope (%)	N/A	N/A	Clear Space?	N/A
	Road X Slope (%)	N/A	N/A	Clear Space to XWalk (in)	N/A
N/A	Any Obstructions?	N/A	N/A	Storm Grate/Utility Hazard?	N/A
	Obstruction Type			Storm Grate/Utility Type	
		N/A			N/A
			Yes	Surface Condition? (G/P)	Good

Possible Solutions:

Remove & Replace Entire Ramp.
