Access Compliance Report

Public Rights-of-Way

(Curb Ramps)

Intersection ID: 11164	Main Street: CAMP_GREENE_ST	Cross Street: FREEDOM_DR	Location: NE
ADA ID: 318B0317A8F5	Ramp Type: Perp	Initial Pass/Fail: Fail	Overall Compliance: No
Severity Score: 12.5			
Codes/Mitigation Info/Possible Solution		Field Measurements/Component Compliance

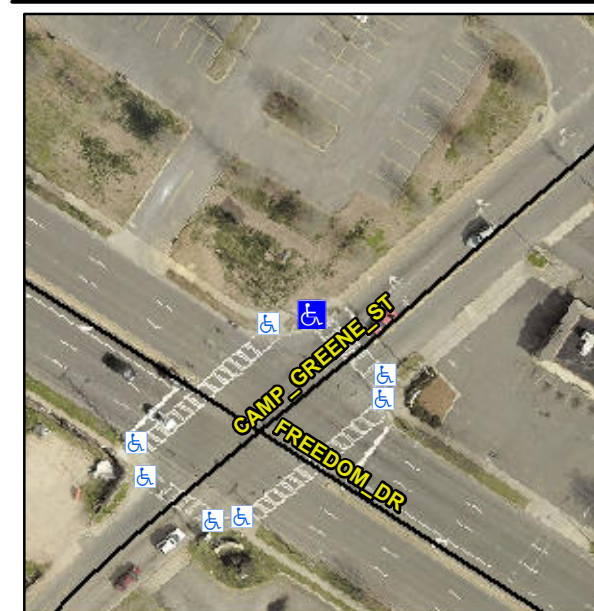
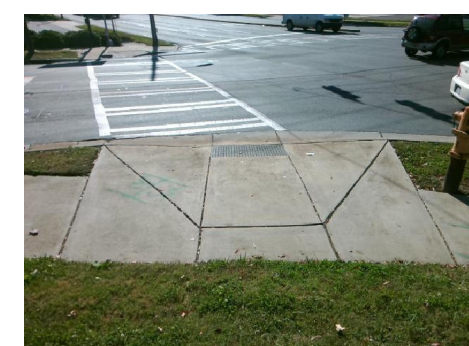
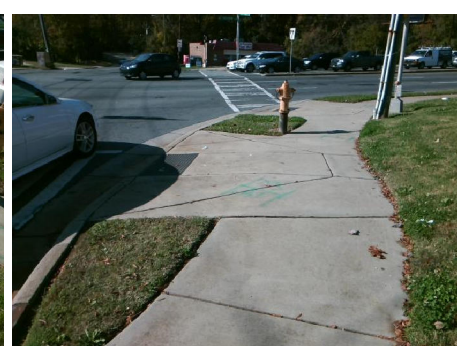
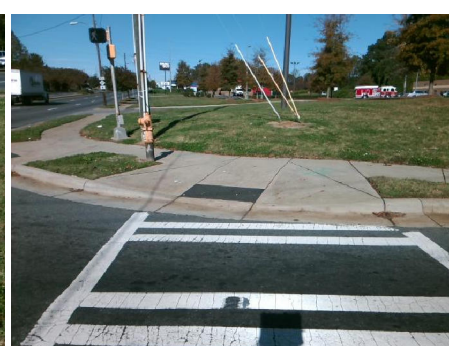
Not Found, R304.2.2

Compliance	Description	Data	Compliance	Description	Data
N/A	Ramp Length (in)	77.0	No	Ramp Slope (%)	10.0
Yes	Ramp Width (in)	48.0	Yes	Ramp XSlope (%)	1.6
N/A	Flare Type LT	N/A	N/A	Flare Type RT	N/A
N/A	Flare Slope LT (%)	N/A	N/A	Flare Slope RT (%)	N/A
N/A	Flare Traversable LT?	N/A	N/A	Flare Traversable RT?	N/A
N/A	Landing Length (in)	N/A	N/A	DWS Provided?	N/A
N/A	Landing Width (in)	N/A	N/A	DWS Contrast?	N/A
N/A	Landing Slope (%)	N/A	N/A	DWS Length (in)	N/A
N/A	Landing X Slope (%)	N/A	N/A	DWS Full Width?	N/A
N/A	Landing Curb? (Y/N)	N/A	N/A	DWS Offset (in)	N/A
N/A	Shared Landing?	N/A			
N/A	Gutter Ponding?	N/A	N/A	Gutter Slope (%)	N/A
N/A	Gutter Lip Ht (in)	N/A	N/A	Gutter X Slope (%)	N/A
N/A	Painted X Walk1?	Yes	N/A	Painted X Walk2?	N/A
	X Walk 1 Direction	To SE		X Walk 2 Direction	N/A
N/A	X Walk 1 Width (in)	95.0	N/A	X Walk 2 Width (in)	N/A
	X Walk 1 Slope (%)	0.5		X Walk 2 Slope (%)	N/A
	X Walk 1 X Slope (%)	2.5		X Walk 2 X Slope (%)	N/A

N/A	Ramp inside XWalk1?	Yes	N/A	Ramp inside XWalk2?	N/A
	Road Slope (%)	N/A	N/A	Clear Space?	N/A
	Road X Slope (%)	N/A	N/A	Clear Space to XWalk (in)	N/A
N/A	Any Obstructions?	N/A	N/A	Storm Grate/Utility Hazard?	N/A
	Obstruction Type			Storm Grate/Utility Type	
		N/A			N/A
		Yes		Surface Condition? (G/P)	Good

Remove & Replace Entire Ramp.
