# Access Compliance Report

## Public Rights-of-Way

### (Curb Ramps)

Intersection ID: 8847	Main Street: E_SUGAR_CREEK_RD	Cross Street: N_TRYON_ST	Location: NE
ADA ID: 318F17CEF356	Ramp Type: Para	Initial Pass/Fail: Fail	Overall Compliance: No
Codes/Mitigation Info/Possible Solution		Field Measurements/Component Compliance	
Severity Score: 13.75

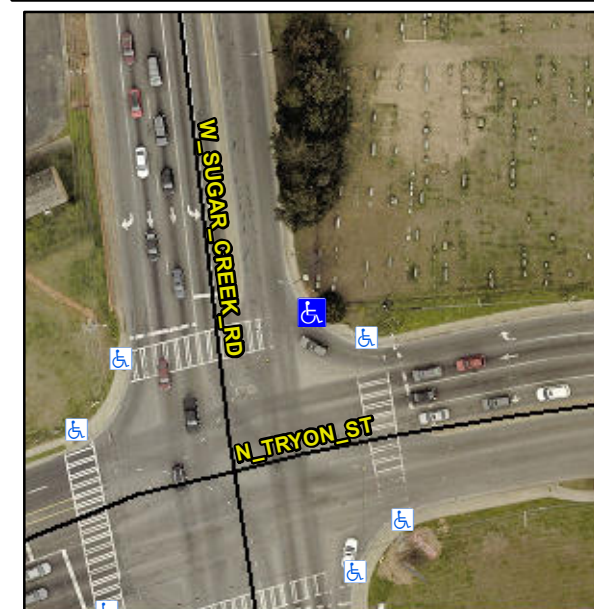
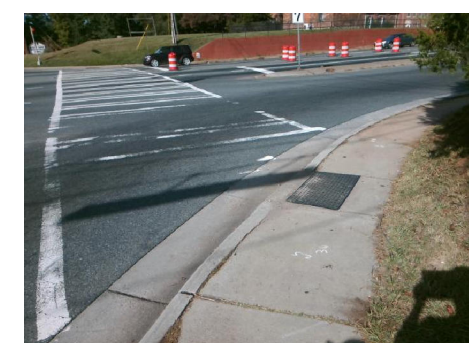
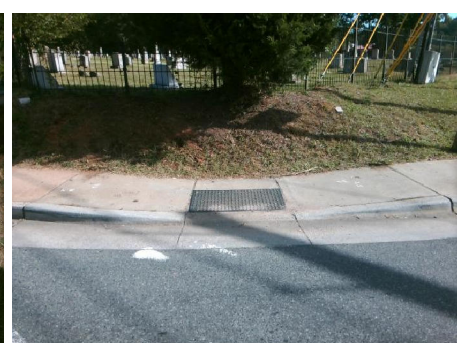
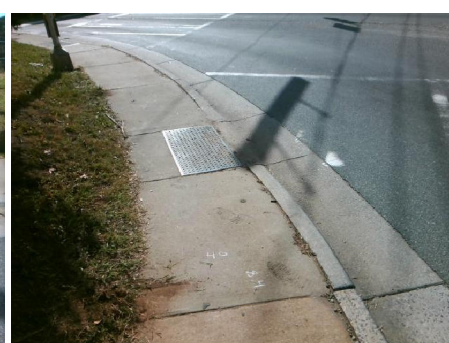
**RT RP < 5%**

**R304.3.2, R304.5.3**

Compliance	Description	Data	Compliance	Description	Data
N/A	Ramp Length LT (in)	66.0	N/A	Ramp Length RT (in)	68.0
Yes	Ramp Width LT (in)	48.0	Yes	Ramp Width RT (in)	48.0
No	Ramp Slope LT (%)	8.4	Yes	Ramp Slope RT (%)	3.6
No	Ramp XSlope LT (%)	4.0	No	Ramp XSlope RT (%)	2.5
N/A	Landing Length (in)	N/A	N/A	DWS Provided?	N/A
N/A	Landing Width (in)	N/A	N/A	DWS Contrast?	N/A
N/A	Landing Slope (%)	N/A	N/A	DWS Length (in)	N/A
N/A	Landing X Slope (%)	N/A	N/A	DWS Full Width?	N/A
N/A	Landing Curb? (Y/N)	N/A	N/A	DWS Offset (in)	N/A
N/A	Shared Landing?	N/A			
N/A	Gutter Ponding?	N/A	N/A	Gutter Slope (%)	N/A
N/A	Gutter Lip Ht (in)	N/A	N/A	Gutter X Slope (%)	N/A
N/A	Painted X Walk1?	Yes	N/A	Painted X Walk2?	N/A
	X Walk 1 Direction	To W		X Walk 2 Direction	N/A
N/A	X Walk 1 Width (in)	181.0	N/A	X Walk 2 Width (in)	N/A
	X Walk 1 Slope (%)	0.7		X Walk 2 Slope (%)	N/A
	X Walk 1 X Slope (%)	3.2		X Walk 2 X Slope (%)	N/A
N/A	Ramp inside XWalk1?	Yes	N/A	Ramp inside XWalk2?	N/A

Road Slope (%)	N/A	N/A	Clear Space?	N/A
	Road X Slope (%)	N/A	N/A	Clear Space to XWalk (in)	N/A
N/A	Any Obstructions?	N/A	N/A	Storm Grate/Utility Hazard?	N/A
	Obstruction Type			Storm Grate/Utility Type	
		N/A			N/A
			Yes	Surface Condition? (G/P)	Good
			N/A	Curb Slope (%)	28.1

Possible Solutions:

**Remove & Replace Entire Ramp.**
