Access Compliance Report

Public Rights-of-Way

(Curb Ramps)

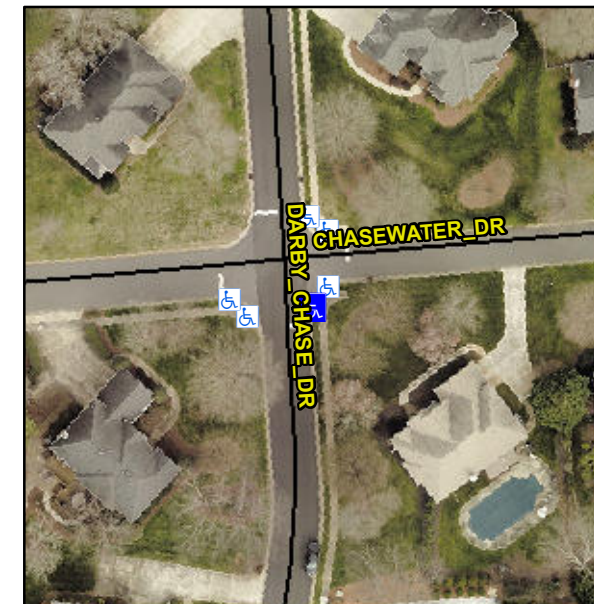
Intersection ID: 42506	Main Street: CHASEWATER_DR	Cross Street: DARBY_CHASE_DR	Location: SE
ADA ID: 3190FF877AD6	Ramp Type: Perp	Initial Pass/Fail: Fail	Overall Compliance: No
Severity Score: 10			
Codes/Mitigation Info/Possible Solution		Field Measurements/Component Compliance

Not Found, R304.5.1, R304.5.3

Compliance	Description	Data	Compliance	Description	Data
N/A	Ramp Length (in)	42.0	Yes	Ramp Slope (%)	6.2
No	Ramp Width (in)	38.5	No	Ramp XSlope (%)	3.5
N/A	Flare Type LT	N/A	N/A	Flare Type RT	N/A
N/A	Flare Slope LT (%)	N/A	N/A	Flare Slope RT (%)	N/A
N/A	Flare Traversable LT?	N/A	N/A	Flare Traversable RT?	N/A
N/A	Landing Length (in)	N/A	N/A	DWS Provided?	N/A
N/A	Landing Width (in)	N/A	N/A	DWS Contrast?	N/A
N/A	Landing Slope (%)	N/A	N/A	DWS Length (in)	N/A
N/A	Landing X Slope (%)	N/A	N/A	DWS Full Width?	N/A
N/A	Landing Curb? (Y/N)	N/A	N/A	DWS Offset (in)	N/A
N/A	Shared Landing?	N/A			
N/A	Gutter Ponding?	N/A	N/A	Gutter Slope (%)	N/A
N/A	Gutter Lip Ht (in)	N/A	N/A	Gutter X Slope (%)	N/A
N/A	Painted X Walk1?	No	N/A	Painted X Walk2?	N/A
	X Walk 1 Direction	To W		X Walk 2 Direction	N/A
N/A	X Walk 1 Width (in)	N/A	N/A	X Walk 2 Width (in)	N/A
	X Walk 1 Slope (%)	2.8		X Walk 2 Slope (%)	N/A
	X Walk 1 X Slope (%)	3.1		X Walk 2 X Slope (%)	N/A

N/A	Ramp inside XWalk1?	N/A	N/A	Ramp inside XWalk2?	N/A
	Road Slope (%)	N/A	N/A	Clear Space?	N/A
	Road X Slope (%)	N/A	N/A	Clear Space to XWalk (in)	N/A
N/A	Any Obstructions?	N/A	N/A	Storm Grate/Utility Hazard?	N/A
	Obstruction Type			Storm Grate/Utility Type	
		N/A			N/A
		Yes		Surface Condition? (G/P)	Good

Possible Solutions:

Remove & Replace Entire Ramp.
