Access Compliance Report

Public Rights-of-Way

(Curb Ramps)

Intersection ID: 12418	Main Street: KILBORNE_DR	Cross Street: MARKHAM_CT	Location: S
ADA ID: 319BBEA338AB	Ramp Type: Perp	Initial Pass/Fail: Fail	Overall Compliance: No
Severity Score: 21.25			
Codes/Mitigation Info/Possible Solution		Field Measurements/Component Compliance

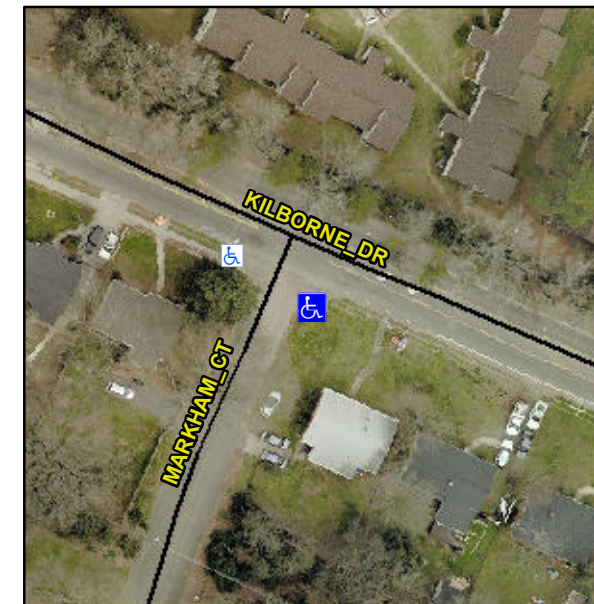
Not Found, R304.5.1, R304.5.3

Compliance	Description	Data	Compliance	Description	Data
N/A	Ramp Length (in)	76.5	Yes	Ramp Slope (%)	7.4
No	Ramp Width (in)	45.5	No	Ramp XSlope (%)	5.9
N/A	Flare Type LT	N/A	N/A	Flare Type RT	N/A
N/A	Flare Slope LT (%)	N/A	N/A	Flare Slope RT (%)	N/A
N/A	Flare Traversable LT?	N/A	N/A	Flare Traversable RT?	N/A
N/A	Landing Length (in)	N/A	N/A	DWS Provided?	N/A
N/A	Landing Width (in)	N/A	N/A	DWS Contrast?	N/A
N/A	Landing Slope (%)	N/A	N/A	DWS Length (in)	N/A
N/A	Landing X Slope (%)	N/A	N/A	DWS Full Width?	N/A
N/A	Landing Curb? (Y/N)	N/A	N/A	DWS Offset (in)	N/A
N/A	Shared Landing?	N/A			
N/A	Gutter Ponding?	N/A	N/A	Gutter Slope (%)	N/A
N/A	Gutter Lip Ht (in)	N/A	N/A	Gutter X Slope (%)	N/A
N/A	Painted X Walk1?	No	N/A	Painted X Walk2?	N/A
	X Walk 1 Direction	To NW		X Walk 2 Direction	N/A
N/A	X Walk 1 Width (in)	N/A	N/A	X Walk 2 Width (in)	N/A
	X Walk 1 Slope (%)	2.9		X Walk 2 Slope (%)	N/A
	X Walk 1 X Slope (%)	4.5		X Walk 2 X Slope (%)	N/A

N/A	Ramp inside XWalk1?	N/A	N/A	Ramp inside XWalk2?	N/A
	Road Slope (%)	N/A	N/A	Clear Space?	N/A
	Road X Slope (%)	N/A	N/A	Clear Space to XWalk (in)	N/A
N/A	Any Obstructions?	N/A	N/A	Storm Grate/Utility Hazard?	N/A
	Obstruction Type			Storm Grate/Utility Type	
		N/A			N/A
			Yes	Surface Condition? (G/P)	Good

Possible Solutions:

Remove & Replace Entire Ramp.

Total Cost: \$ 1850.00
