Access Compliance Report

Public Rights-of-Way

(Curb Ramps)

Intersection ID: 12833	Main Street: HICKORY GROVE RD	Cross Street: VALLEYVIEW DR	Location: NE
ADA ID: 31A05D5E851F	Ramp Type: PerpDiag	Initial Pass/Fail: Fail	Overall Compliance: No
Severity Score: 10			
Codes/Mitigation Info/Possible Solution		Field Measurements/Component Compliance

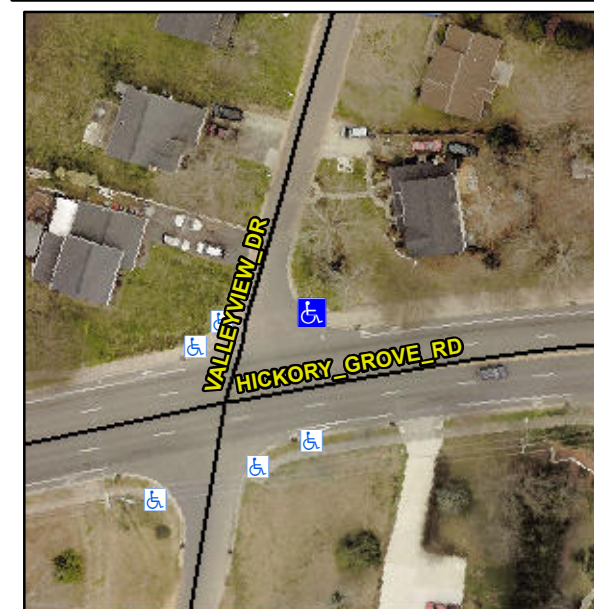
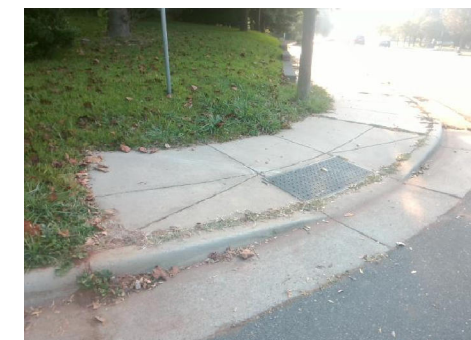
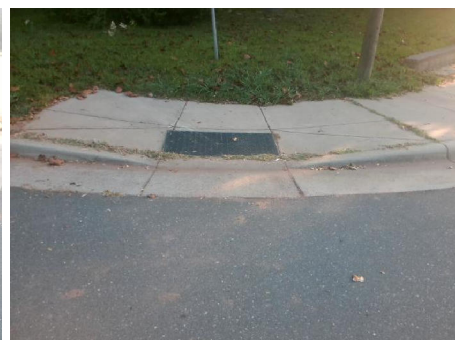
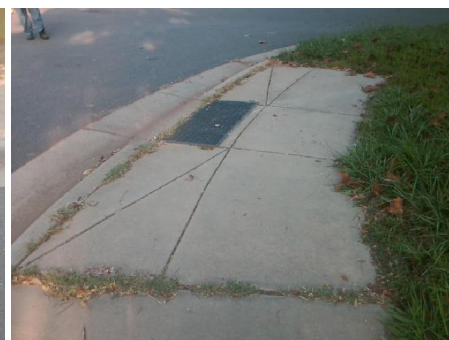
Not Found, R304.5.1, R304.5.3

Compliance	Description	Data	Compliance	Description	Data
N/A	Ramp Length (in)	30.5	Yes	Ramp Slope (%)	7.9
No	Ramp Width (in)	44.5	No	Ramp XSlope (%)	2.5
N/A	Flare Type LT	N/A	N/A	Flare Type RT	N/A
N/A	Flare Slope LT (%)	N/A	N/A	Flare Slope RT (%)	N/A
N/A	Flare Traversable LT?	N/A	N/A	Flare Traversable RT?	N/A
N/A	Landing Length (in)	N/A	N/A	DWS Provided?	N/A
N/A	Landing Width (in)	N/A	N/A	DWS Contrast?	N/A
N/A	Landing Slope (%)	N/A	N/A	DWS Length (in)	N/A
N/A	Landing X Slope (%)	N/A	N/A	DWS Full Width?	N/A
N/A	Landing Curb? (Y/N)	N/A	N/A	DWS Offset (in)	N/A
N/A	Shared Landing?	N/A			
N/A	Gutter Ponding?	N/A	N/A	Gutter Slope (%)	N/A
N/A	Gutter Lip Ht (in)	N/A	N/A	Gutter X Slope (%)	N/A
N/A	Painted X Walk1?	No	N/A	Painted X Walk2?	No
	X Walk 1 Direction	To W		X Walk 2 Direction	To S
N/A	X Walk 1 Width (in)	N/A	N/A	X Walk 2 Width (in)	N/A
	X Walk 1 Slope (%)	1.2		X Walk 2 Slope (%)	0.6
	X Walk 1 X Slope (%)	0.6		X Walk 2 X Slope (%)	4.0

N/A	Ramp inside XWalk1?	N/A	N/A	Ramp inside XWalk2?	N/A
	Road Slope (%)	0.7	N/A	Clear Space?	N/A
	Road X Slope (%)	1.4	N/A	Clear Space to XWalk (in)	N/A
N/A	Any Obstructions?	N/A	N/A	Storm Grate/Utility Hazard?	N/A
	Obstruction Type			Storm Grate/Utility Type	
		N/A			N/A
		Yes		Surface Condition? (G/P)	Good

Remove & Replace Curb Ramp With Two New Directional Ramps or Equivalent.
