Access Compliance Report

Public Rights-of-Way

(Curb Ramps)

Intersection ID: 10028419	Main Street: HIGHGROVE_ST	Cross Street: N/A	Location: SE
ADA ID: 31A2254A32A6	Ramp Type: Perp	Initial Pass/Fail: Fail	Overall Compliance: No
		Severity Score: 25

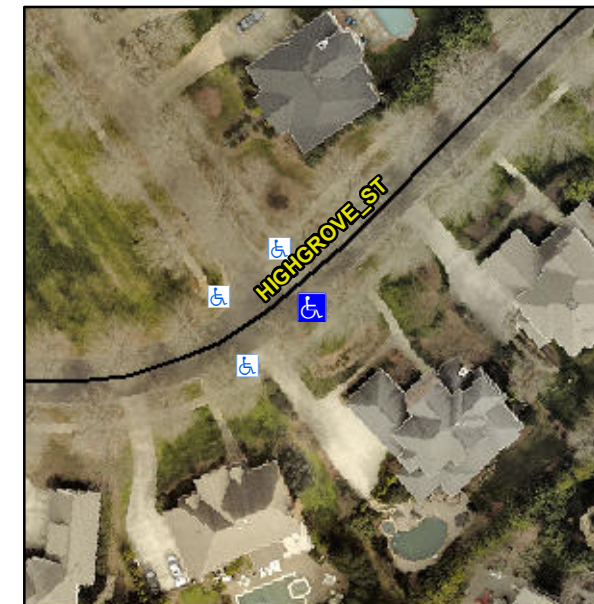
Not Found, R304.2.2

Compliance	Description	Data	Compliance	Description	Data
N/A	Ramp Length (in)	92.0	No	Ramp Slope (%)	12.6
Yes	Ramp Width (in)	56.0	Yes	Ramp XSlope (%)	1.1
N/A	Flare Type LT	N/A	N/A	Flare Type RT	N/A
N/A	Flare Slope LT (%)	N/A	N/A	Flare Slope RT (%)	N/A
N/A	Flare Traversable LT?	N/A	N/A	Flare Traversable RT?	N/A
N/A	Landing Length (in)	N/A	N/A	DWS Provided?	N/A
N/A	Landing Width (in)	N/A	N/A	DWS Contrast?	N/A
N/A	Landing Slope (%)	N/A	N/A	DWS Length (in)	N/A
N/A	Landing X Slope (%)	N/A	N/A	DWS Full Width?	N/A
N/A	Landing Curb? (Y/N)	N/A	N/A	DWS Offset (in)	N/A
N/A	Shared Landing?	N/A			
N/A	Gutter Ponding?	N/A	N/A	Gutter Slope (%)	N/A
N/A	Gutter Lip Ht (in)	N/A	N/A	Gutter X Slope (%)	N/A
N/A	Painted X Walk1?	No	N/A	Painted X Walk2?	N/A
	X Walk 1 Direction	To NW		X Walk 2 Direction	N/A
N/A	X Walk 1 Width (in)	N/A	N/A	X Walk 2 Width (in)	N/A
	X Walk 1 Slope (%)	3.3		X Walk 2 Slope (%)	N/A
	X Walk 1 X Slope (%)	3.2		X Walk 2 X Slope (%)	N/A

N/A	Ramp inside XWalk1?	N/A	N/A	Ramp inside XWalk2?	N/A
	Road Slope (%)	N/A	N/A	Clear Space?	N/A
	Road X Slope (%)	N/A	N/A	Clear Space to XWalk (in)	N/A
N/A	Any Obstructions?	N/A	N/A	Storm Grate/Utility Hazard?	N/A
	Obstruction Type			Storm Grate/Utility Type	
		N/A			N/A
			Yes	Surface Condition? (G/P)	Good

Remove & Replace Entire Ramp.

Total Cost: \$ 1850.00
