Access Compliance Report

Public Rights-of-Way

(Curb Ramps)

Intersection ID: 14314	Main Street: E_TREMONT_AV	Cross Street: SOUTH_BV	Location: NW
ADA ID: 31A5E29CF5FF	Ramp Type: Perp	Initial Pass/Fail: Fail	Overall Compliance: No
		Severity Score: 12.5

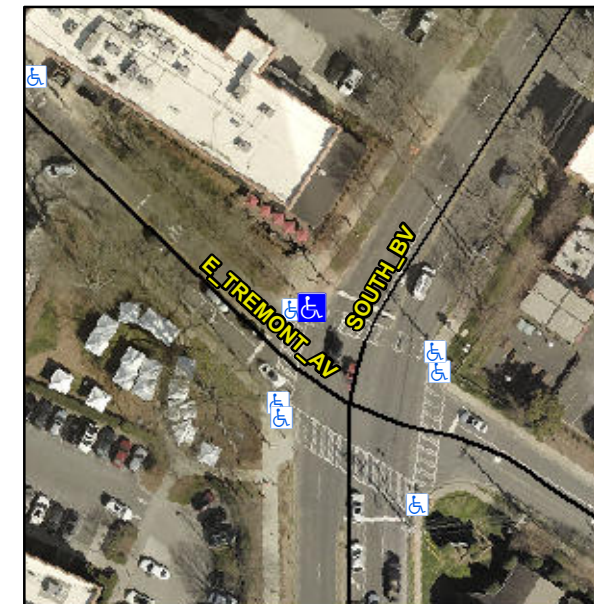
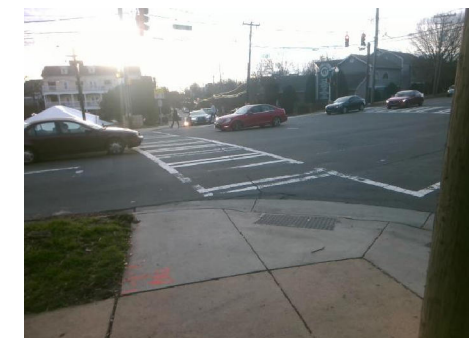
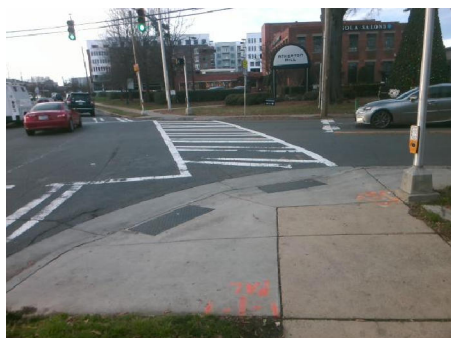
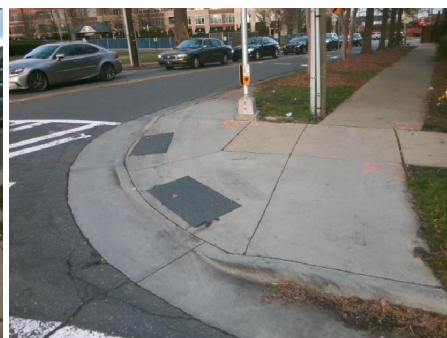
Compliance	Description	Data	Compliance	Description	Data
N/A	Ramp Length (in)	71.0	No	Ramp Slope (%)	8.7
Yes	Ramp Width (in)	48.0	Yes	Ramp XSlope (%)	1.8
N/A	Flare Type LT	N/A	N/A	Flare Type RT	N/A
N/A	Flare Slope LT (%)	N/A	N/A	Flare Slope RT (%)	N/A
N/A	Flare Traversable LT?	N/A	N/A	Flare Traversable RT?	N/A
N/A	Landing Length (in)	N/A	N/A	DWS Provided?	N/A
N/A	Landing Width (in)	N/A	N/A	DWS Contrast?	N/A
N/A	Landing Slope (%)	N/A	N/A	DWS Length (in)	N/A
N/A	Landing X Slope (%)	N/A	N/A	DWS Full Width?	N/A
N/A	Landing Curb? (Y/N)	N/A	N/A	DWS Offset (in)	N/A
N/A	Shared Landing?	N/A			
N/A	Gutter Ponding?	N/A	N/A	Gutter Slope (%)	N/A
N/A	Gutter Lip Ht (in)	N/A	N/A	Gutter X Slope (%)	N/A
N/A	Painted X Walk1?	Yes	N/A	Painted X Walk2?	N/A
	X Walk 1 Direction	To SE		X Walk 2 Direction	N/A
N/A	X Walk 1 Width (in)	114.0	N/A	X Walk 2 Width (in)	N/A
	X Walk 1 Slope (%)	4.2		X Walk 2 Slope (%)	N/A
	X Walk 1 X Slope (%)	3.8		X Walk 2 X Slope (%)	N/A

N/A	Ramp inside XWalk1?	Yes	N/A	Ramp inside XWalk2?	N/A
	Road Slope (%)	N/A	N/A	Clear Space?	N/A
	Road X Slope (%)	N/A	N/A	Clear Space to XWalk (in)	N/A
N/A	Any Obstructions?	N/A	N/A	Storm Grate/Utility Hazard?	N/A
	Obstruction Type			Storm Grate/Utility Type	
		N/A			N/A
		Yes		Surface Condition? (G/P)	Good

Possible Solutions:

Remove & Replace Entire Ramp.

Total Cost:

\$ 1850.00
