Access Compliance Report

Public Rights-of-Way

(Curb Ramps)

| Intersection ID: 32312 | Main Street: CAMBRIDGE_WOODS_CT | Cross Street: TRAVIS_GULCH_DR | Location: SE |

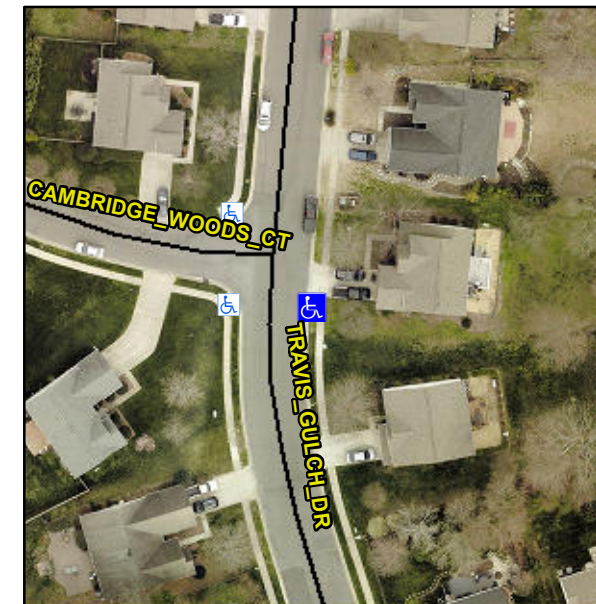
| ADA ID: 31B12D2BE7A9 | Ramp Type: BlendTrans1 | Initial Pass/Fail: Fail | Overall Compliance: No |
| Severity Score: 8.75 | | | |

Not Found, R304.5.1

| Compliance | Description | Data | Compliance | Description | Data |
|---|---|---|---|---|---|
| No | Ramp Width (in) | 39.0 | Yes | BlendTrans XSlope (%) | 1.2 |
| | | | No | Curb Slope (%) | 9.6 |

Remove & Replace Curb Ramp With Two New Directional Ramps or Equivalent.

Total Cost: \$ 3200.00
