Access Compliance Report

Public Rights-of-Way

(Curb Ramps)

Intersection ID: 23240	Main Street: SOUTH_COMMERCE_BV	Cross Street: WESTINGHOUSE_BV	Location: E
ADA ID: 31BEF173B042	Ramp Type: PerpDiag	Initial Pass/Fail: Fail	Overall Compliance: No
			Severity Score: 21.25

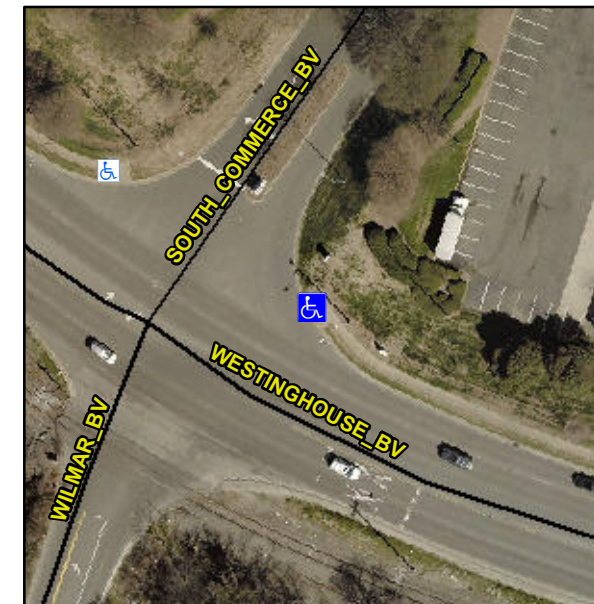
Compliance	Description	Data	Compliance	Description	Data
N/A	Ramp Length (in)	111.0	No	Ramp Slope (%)	8.7
No	Ramp Width (in)	45.0	Yes	Ramp XSlope (%)	1.7
N/A	Flare Type LT	N/A	N/A	Flare Type RT	N/A
N/A	Flare Slope LT (%)	N/A	N/A	Flare Slope RT (%)	N/A
N/A	Flare Traversable LT?	N/A	N/A	Flare Traversable RT?	N/A
N/A	Landing Length (in)	N/A	N/A	DWS Provided?	N/A
N/A	Landing Width (in)	N/A	N/A	DWS Contrast?	N/A
N/A	Landing Slope (%)	N/A	N/A	DWS Length (in)	N/A
N/A	Landing X Slope (%)	N/A	N/A	DWS Full Width?	N/A
N/A	Landing Curb? (Y/N)	N/A	N/A	DWS Offset (in)	N/A
N/A	Shared Landing?	N/A			
N/A	Gutter Ponding?	N/A	N/A	Gutter Slope (%)	N/A
N/A	Gutter Lip Ht (in)	N/A	N/A	Gutter X Slope (%)	N/A
N/A	Painted X Walk1?	No	N/A	Painted X Walk2?	No
	X Walk 1 Direction	To NW		X Walk 2 Direction	To SW
N/A	X Walk 1 Width (in)	N/A	N/A	X Walk 2 Width (in)	N/A
	X Walk 1 Slope (%)	0.6		X Walk 2 Slope (%)	1.5
	X Walk 1 X Slope (%)	2.3		X Walk 2 X Slope (%)	0.5

N/A	Ramp inside XWalk1?	N/A	N/A	Ramp inside XWalk2?	N/A
	Road Slope (%)	1.0	N/A	Clear Space?	N/A
	Road X Slope (%)	3.4	N/A	Clear Space to XWalk (in)	N/A
N/A	Any Obstructions?	N/A	N/A	Storm Grate/Utility Hazard?	N/A
	Obstruction Type			Storm Grate/Utility Type	
		N/A			N/A
			Yes	Surface Condition? (G/P)	Good

Remove & Replace Curb Ramp With Two New Directional Ramps or Equivalent.

R304.5.1, R304.2.2
