Access Compliance Report

Public Rights-of-Way

(Curb Ramps)

Intersection ID: N/A	Main Street: COUNTRY_WALK_DR	Cross Street: NATURE_WALK_DR	Location: S
ADA ID: 31C80780F973	Ramp Type: PerpDiag	Initial Pass/Fail: Fail	Overall Compliance: No
		Severity Score: 22.5

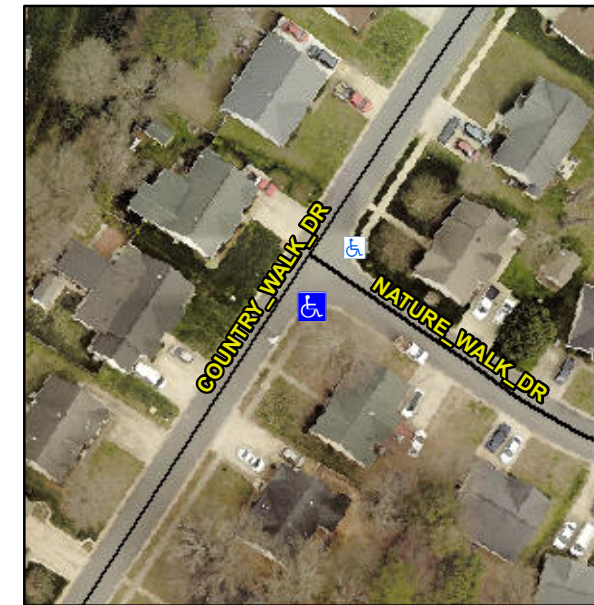
Not Found, R304.5.1, R304.2.2, R304.5.3

Compliance	Description	Data	Compliance	Description	Data
N/A	Ramp Length (in)	47.5	No	Ramp Slope (%)	9.1
No	Ramp Width (in)	46.5	No	Ramp XSlope (%)	4.7
N/A	Flare Type LT	N/A	N/A	Flare Type RT	N/A
N/A	Flare Slope LT (%)	N/A	N/A	Flare Slope RT (%)	N/A
N/A	Flare Traversable LT?	N/A	N/A	Flare Traversable RT?	N/A
N/A	Landing Length (in)	N/A	N/A	DWS Provided?	N/A
N/A	Landing Width (in)	N/A	N/A	DWS Contrast?	N/A
N/A	Landing Slope (%)	N/A	N/A	DWS Length (in)	N/A
N/A	Landing X Slope (%)	N/A	N/A	DWS Full Width?	N/A
N/A	Landing Curb? (Y/N)	N/A	N/A	DWS Offset (in)	N/A
N/A	Shared Landing?	N/A			
N/A	Gutter Ponding?	N/A	N/A	Gutter Slope (%)	N/A
N/A	Gutter Lip Ht (in)	N/A	N/A	Gutter X Slope (%)	N/A
N/A	Painted X Walk1?	No	N/A	Painted X Walk2?	No
	X Walk 1 Direction	To NE		X Walk 2 Direction	To NW
N/A	X Walk 1 Width (in)	N/A	N/A	X Walk 2 Width (in)	N/A
	X Walk 1 Slope (%)	1.0		X Walk 2 Slope (%)	6.1
	X Walk 1 X Slope (%)	3.6		X Walk 2 X Slope (%)	1.2

N/A	Ramp inside XWalk1?	N/A	N/A	Ramp inside XWalk2?	N/A
	Road Slope (%)	2.8	N/A	Clear Space?	N/A
	Road X Slope (%)	5.3	N/A	Clear Space to XWalk (in)	N/A
N/A	Any Obstructions?	N/A	N/A	Storm Grate/Utility Hazard?	N/A
	Obstruction Type			Storm Grate/Utility Type	
		N/A			N/A
			Yes	Surface Condition? (G/P)	Good

Remove & Replace Curb Ramp With Two New Directional Ramps or Equivalent.
