Access Compliance Report

Public Rights-of-Way

(Curb Ramps)

Intersection ID: 44958	Main Street: N_TRYON_ST	Cross Street: OLD_CONCORD_RD	Location: NW
ADA ID: 31C8D3A31675	Ramp Type: Perp	Initial Pass/Fail: Fail	Overall Compliance: No
Severity Score: 12.5			
Codes/Mitigation Info/Possible Solution		Field Measurements/Component Compliance

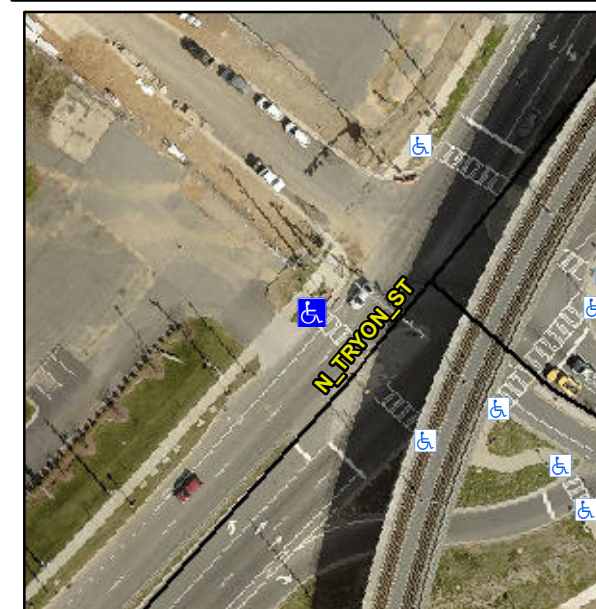
Not Found, R304.2.2

Compliance	Description	Data	Compliance	Description	Data
N/A	Ramp Length (in)	101.0	No	Ramp Slope (%)	8.7
Yes	Ramp Width (in)	95.0	Yes	Ramp XSlope (%)	1.5
N/A	Flare Type LT	N/A	N/A	Flare Type RT	N/A
N/A	Flare Slope LT (%)	N/A	N/A	Flare Slope RT (%)	N/A
N/A	Flare Traversable LT?	N/A	N/A	Flare Traversable RT?	N/A
N/A	Landing Length (in)	N/A	N/A	DWS Provided?	N/A
N/A	Landing Width (in)	N/A	N/A	DWS Contrast?	N/A
N/A	Landing Slope (%)	N/A	N/A	DWS Length (in)	N/A
N/A	Landing X Slope (%)	N/A	N/A	DWS Full Width?	N/A
N/A	Landing Curb? (Y/N)	N/A	N/A	DWS Offset (in)	N/A
N/A	Shared Landing?	N/A			
N/A	Gutter Ponding?	N/A	N/A	Gutter Slope (%)	N/A
N/A	Gutter Lip Ht (in)	N/A	N/A	Gutter X Slope (%)	N/A
N/A	Painted X Walk1?	Yes	N/A	Painted X Walk2?	N/A
	X Walk 1 Direction	To SE		X Walk 2 Direction	N/A
N/A	X Walk 1 Width (in)	120.0	N/A	X Walk 2 Width (in)	N/A
	X Walk 1 Slope (%)	2.4		X Walk 2 Slope (%)	N/A
	X Walk 1 X Slope (%)	1.6		X Walk 2 X Slope (%)	N/A

Possible Solutions:

Remove & Replace Entire Ramp.
