## **Access Compliance Report Public Rights-of-Way** (Curb Ramps)

Intersection ID: 29650 Main Street: MILLERS CREEK LN **Cross Street: SOUTHERN GARDEN LN** Location: NE ADA ID: 31E542F11F93 Ramp Type: PerpDiag Initial Pass/Fail: Fail **Overall Compliance: No Severity Score:** 35

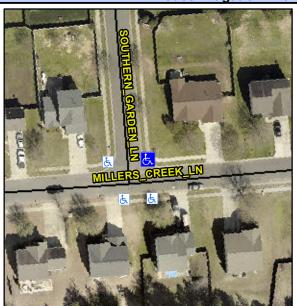
| Field Measurements/Component Compliance | | | | | |
|---|---|---|---|---|---|
| No | Ramp Width (in) | 30.0 | Yes | Ramp XSlope (%) | 0.4 |

Possible Solutions: **Remove & Replace Curb Ramp With** Two New Directional Ramps or Equivalent. Surveyor Notes: N/A PROW/ADA: Not Found, R304.5.1
