Access Compliance Report

Public Rights-of-Way

| Intersection ID: 16241 | Main Street: IDLEWOOD_CR | Cross Street: LILAC_RD | Location: NE |
| ADA ID: 31F51DF7A6E5 | Ramp Type: PerpDiag | Initial Pass/Fail: Fail | Overall Compliance: No |

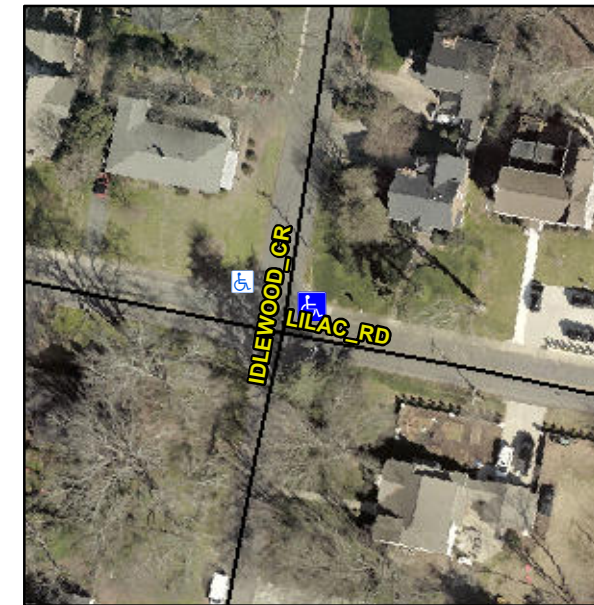
R304.2.2, R304.5.3

| Compliance | Description | Data | Compliance | Description | Data |
|---|---|---|---|---|---|
| N/A | Ramp Length (in) | 62.0 | No | Ramp Slope (%) | 9.9 |
| Yes | Ramp Width (in) | 48.0 | No | Ramp XSlope (%) | 5.8 |

Remove & Replace Curb Ramp With Two New Directional Ramps or Equivalent.
