Access Compliance Report Public Rights-of-Way (Curb Ramps)

Intersection ID: 53704 Main Street: MILLSTREAM RIDGE DR Cross Street: MILLSTREAM RIDGE DR W Location: **Severity Score:** 10 **ADA ID: 31FD2C263FE3** Ramp Type: Combination1 Initial Pass/Fail: Fail **Overall Compliance: No**

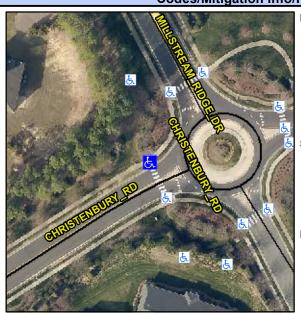
Compliance Description Possible Solutions: N/A Remove & Replace Entire Ramp. Yes Yes Yes N/A No Surveyor Notes: N/A LT RP < 5% N/A PROW/ADA: R304.5.1, R304.5.3
