Access Compliance Report

Public Rights-of-Way

(Curb Ramps)

Intersection ID: 31889	Main Street: MT_MANSFIELD_RD	Cross Street: SPRUCE_PEAK_RD	Location: SW
ADA ID: 3201422F9A08	Ramp Type: PerpDiag	Initial Pass/Fail: Fail	Overall Compliance: No
Severity Score: 8.75			
Codes/Mitigation Info/Possible Solution		Field Measurements/Component Compliance

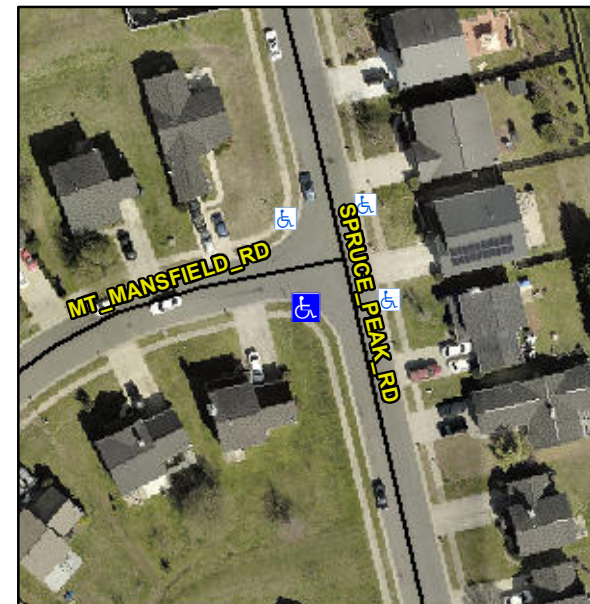
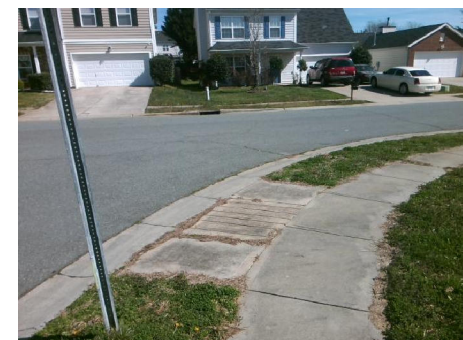
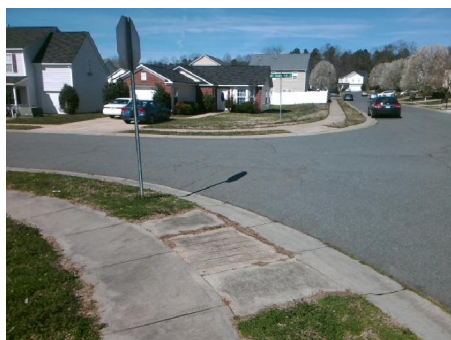
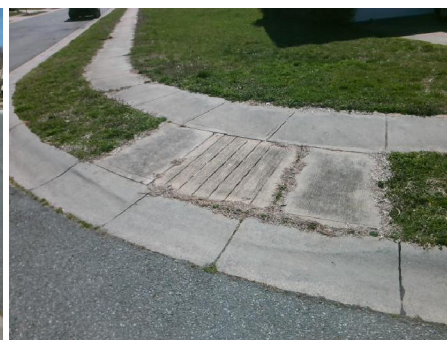
R304.5.1

Compliance	Description	Data	Compliance	Description	Data
N/A	Ramp Length (in)	48.0	Yes	Ramp Slope (%)	7.7
No	Ramp Width (in)	39.0	Yes	Ramp XSlope (%)	1.6
N/A	Flare Type LT	N/A	N/A	Flare Type RT	N/A
N/A	Flare Slope LT (%)	N/A	N/A	Flare Slope RT (%)	N/A
N/A	Flare Traversable LT?	N/A	N/A	Flare Traversable RT?	N/A
N/A	Landing Length (in)	N/A	N/A	DWS Provided?	N/A
N/A	Landing Width (in)	N/A	N/A	DWS Contrast?	N/A
N/A	Landing Slope (%)	N/A	N/A	DWS Length (in)	N/A
N/A	Landing X Slope (%)	N/A	N/A	DWS Full Width?	N/A
N/A	Landing Curb? (Y/N)	N/A	N/A	DWS Offset (in)	N/A
N/A	Shared Landing?	N/A			
N/A	Gutter Ponding?	N/A	N/A	Gutter Slope (%)	N/A
N/A	Gutter Lip Ht (in)	N/A	N/A	Gutter X Slope (%)	N/A
N/A	Painted X Walk1?	No	N/A	Painted X Walk2?	No
	X Walk 1 Direction	To E		X Walk 2 Direction	To N
N/A	X Walk 1 Width (in)	N/A	N/A	X Walk 2 Width (in)	N/A
	X Walk 1 Slope (%)	4.2		X Walk 2 Slope (%)	3.1
	X Walk 1 X Slope (%)	2.1		X Walk 2 X Slope (%)	1.9

N/A	Ramp inside XWalk1?	N/A	N/A	Ramp inside XWalk2?	N/A
	Road Slope (%)	1.0	N/A	Clear Space?	N/A
	Road X Slope (%)	5.4	N/A	Clear Space to XWalk (in)	N/A
N/A	Any Obstructions?	N/A	N/A	Storm Grate/Utility Hazard?	N/A
	Obstruction Type			Storm Grate/Utility Type	
		N/A			N/A
		Yes		Surface Condition? (G/P)	Good

Remove & Replace Curb Ramp With Two New Directional Ramps or Equivalent.
