Intersection ID: N/A	Main Street: 24TH_ST	Cross Street: N/A	Location:	NW
ADA ID: 32105865A782	Ramp Type: ParaDiag	Initial Pass/Fail: Pass	Overall Compliance: No	Severity Score: 0.25

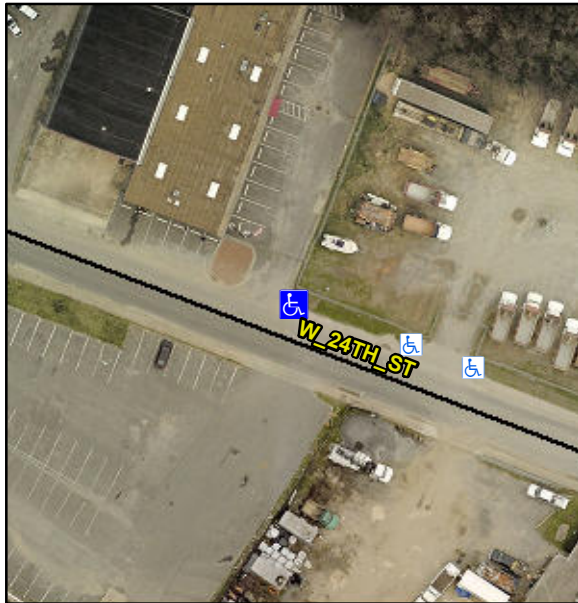
PONDING PREVENTED GTR SLOPES

R304.5.3, R304.2.2-Perp, R304.3.2-Para, R302.7, R304.5.4

Remove & Replace Curb Ramp With Two New Directional Ramps or Equivalent. Remove & Replace Gutter.

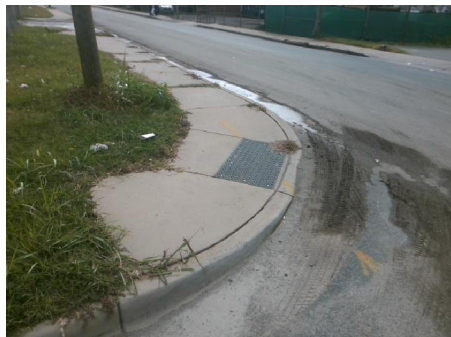
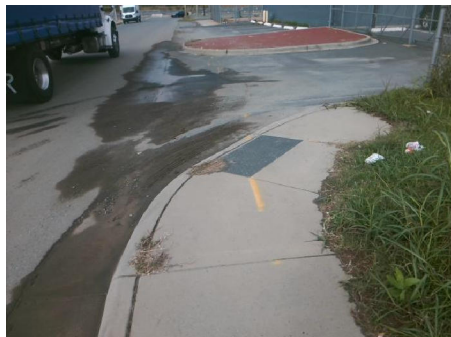
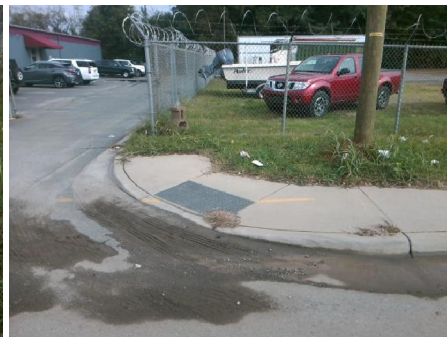
N/A	X Walk 1 Width (in)	N/A	N/A	X Walk 2 Width (in)	N/A		
		X Walk 1 Slope (%)	2.2		X Walk 2 Slope (%)	2.1		
		X Walk 1 X Slope (%)	2.1		X Walk 2 X Slope (%)	0.6		
	N/A	Ramp inside XWalk1?	N/A	N/A	Ramp inside XWalk2?	N/A		
		Road Slope (%)	0.2	N/A	Clear Space?	Yes		
		Road X Slope (%)	5.8	N/A	Clear Space to XWalk (in)	N/A		
Surveyor Notes:	Yes	Any Obstructions?	No	Yes	Storm Grate/Utility Hazard?	No		
		Obstruction Type			Storm Grate/Utility Type			
PROW/ADA:								
R304.5.3, R304.2.2-Perp, R304.3.2-Para, R302.7, R304.5.4								
Total Cost:								
	\$	3950.00		N/A		N/A		
					Yes	Surface Condition? (G/P)	Good	
				N/A	Curb Slope (%)	11.5
