# Access Compliance Report

## Public Rights-of-Way

### (Curb Ramps)

Intersection ID: 10041631	Main Street: WHITEHALL_PARK_DR	Cross Street: N/A	Location: SE
ADA ID: 321592D5B60C	Ramp Type: PerpDiag	Initial Pass/Fail: Fail	Overall Compliance: No
Codes/Mitigation Info/Possible Solution		Field Measurements/Component Compliance	
Severity Score: 8.75

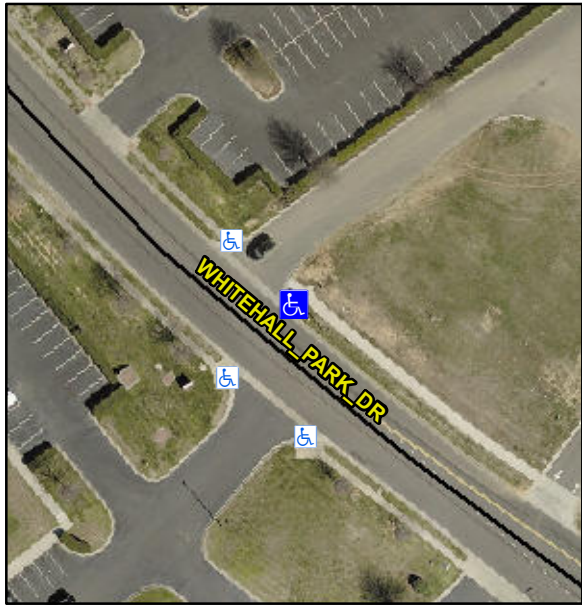
<b>Possible Solutions:</b>							
	<b>Remove &amp; Replace Curb Ramp With Two New Directional Ramps or Equivalent.</b>		<b>Compliance</b>	<b>Description</b>	<b>Data</b>	<b>Compliance</b>	<b>Description</b>	<b>Data</b>
	<b>N/A</b>	Ramp Length (in)	<b>55.0</b>	<b>Yes</b>	Ramp Slope (%)	<b>5.5</b>		
	<b>No</b>	Ramp Width (in)	<b>43.0</b>	<b>Yes</b>	Ramp XSlope (%)	<b>0.9</b>		
	<b>N/A</b>	Flare Type LT	<b>N/A</b>	<b>N/A</b>	Flare Type RT	<b>N/A</b>		
	<b>N/A</b>	Flare Slope LT (%)	<b>N/A</b>	<b>N/A</b>	Flare Slope RT (%)	<b>N/A</b>		
	<b>N/A</b>	Flare Traversable LT?	<b>N/A</b>	<b>N/A</b>	Flare Traversable RT?	<b>N/A</b>		
	<b>N/A</b>	Landing Length (in)	<b>N/A</b>	<b>N/A</b>	DWS Provided?	<b>N/A</b>		
	<b>N/A</b>	Landing Width (in)	<b>N/A</b>	<b>N/A</b>	DWS Contrast?	<b>N/A</b>		
	<b>N/A</b>	Landing Slope (%)	<b>N/A</b>	<b>N/A</b>	DWS Length (in)	<b>N/A</b>		
<p>Surveyor Notes:</p> <p><b>N/A</b></p> <p>PROW/ADA:</p> <p><b>R304.5.1</b></p>	<b>N/A</b>	Landing X Slope (%)	<b>N/A</b>	<b>N/A</b>	DWS Full Width?	<b>N/A</b>

<b>N/A</b>	Landing Curb? (Y/N)	<b>N/A</b>	<b>N/A</b>	DWS Offset (in)	<b>N/A</b>		
	<b>N/A</b>	Shared Landing?	<b>N/A</b>					
	<b>N/A</b>	Gutter Ponding?	<b>N/A</b>	<b>N/A</b>	Gutter Slope (%)	<b>N/A</b>		
	<b>N/A</b>	Gutter Lip Ht (in)	<b>N/A</b>	<b>N/A</b>	Gutter X Slope (%)	<b>N/A</b>		
	<b>N/A</b>	Painted X Walk1?	<b>No</b>	<b>N/A</b>	Painted X Walk2?	<b>No</b>		
		X Walk 1 Direction	<b>To NW</b>		X Walk 2 Direction	<b>To SW</b>		
	<b>N/A</b>	X Walk 1 Width (in)	<b>N/A</b>	<b>N/A</b>	X Walk 2 Width (in)	<b>N/A</b>		
		X Walk 1 Slope (%)	<b>0.3</b>		X Walk 2 Slope (%)	<b>7.0</b>		
		X Walk 1 X Slope (%)	<b>0.5</b>		X Walk 2 X Slope (%)	<b>3.0</b>		
<p>Street 1 Name</p> <p><b>ENTRANCE</b></p> <p>Stop Condition-Street 2</p> <p><b>StopSign</b></p> <p>Street 2 Name</p> <p><b>WHITEHALL PARK DR</b></p> <p>Stop Condition-Street 1</p> <p><b>None</b></p>	<b>N/A</b>	Ramp inside XWalk1?	<b>N/A</b>	<b>N/A</b>	Ramp inside XWalk2?	<b>N/A</b>

Road Slope (%)	<b>3.2</b>	<b>N/A</b>	Clear Space?	<b>N/A</b>		
		Road X Slope (%)	<b>0.4</b>	<b>N/A</b>	Clear Space to XWalk (in)	<b>N/A</b>		
	<b>N/A</b>	Any Obstructions?	<b>N/A</b>	<b>N/A</b>	Storm Grate/Utility Hazard?	<b>N/A</b>		
		Obstruction Type			Storm Grate/Utility Type			
			<b>N/A</b>			<b>N/A</b>		
				<b>Yes</b>	Surface Condition? (G/P)	<b>Good</b>		
Total Cost:		<b>\$</b>	<b>3200.00</b>
