Access Compliance Report

Public Rights-of-Way

(Curb Ramps)

Intersection ID: N/A	Main Street: W_W_T_HARRIS_BV	Cross Street: N/A	Location: NW
ADA ID: 3215F63E0AFB	Ramp Type: Perp	Initial Pass/Fail: Pass	Overall Compliance: No
		Severity Score: 7.75	
Codes/Mitigation Info/Possible Solution		Field Measurements/Component Compliance

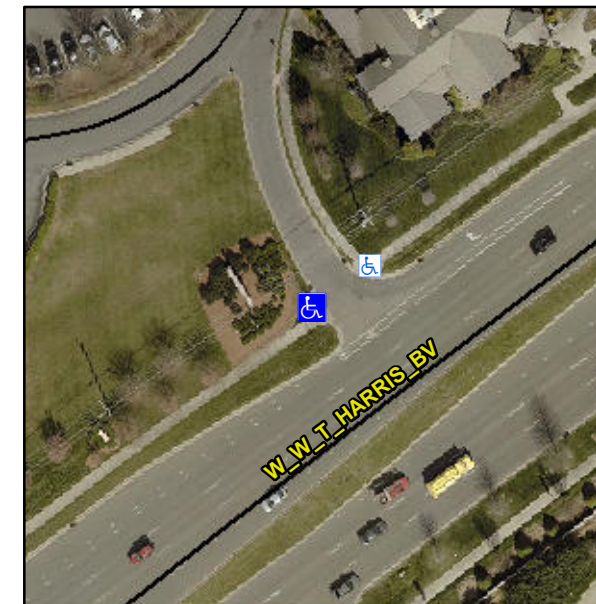
Compliance	Description	Data	Compliance	Description	Data
N/A	Ramp Length (in)	84.0	Yes	Ramp Slope (%)	5.3
Yes	Ramp Width (in)	48.0	No	Ramp XSlope (%)	2.8
N/A	Flare Type LT	Sloped	N/A	Flare Type RT	N/A
N/A	Flare Slope LT (%)	7.2	N/A	Flare Slope RT (%)	2.5
N/A	Flare Traversable LT?	No	N/A	Flare Traversable RT?	No
No	Landing Length (in)	44.0	Yes	DWS Provided?	Yes
Yes	Landing Width (in)	72.0	Yes	DWS Contrast?	Yes
No	Landing Slope (%)	4.3	Yes	DWS Length (in)	25.5
Yes	Landing X Slope (%)	1.2	Yes	DWS Full Width?	Yes
N/A	Landing Curb? (Y/N)	No	Yes	DWS Offset (in)	2.0
N/A	Shared Landing?	No			
Yes	Gutter Ponding?	No	Yes	Gutter Slope (%)	4.3
No	Gutter Lip Ht (in)	0.5	Yes	Gutter X Slope (%)	0.5
N/A	Painted X Walk1?	No	N/A	Painted X Walk2?	N/A
	X Walk 1 Direction	To NE		X Walk 2 Direction	N/A
N/A	X Walk 1 Width (in)	N/A	N/A	X Walk 2 Width (in)	N/A
	X Walk 1 Slope (%)	1.8		X Walk 2 Slope (%)	N/A
	X Walk 1 X Slope (%)	1.3		X Walk 2 X Slope (%)	N/A

N/A	Ramp inside XWalk1?	N/A	N/A	Ramp inside XWalk2?	N/A
	Road Slope (%)	N/A	N/A	Clear Space?	Yes
	Road X Slope (%)	N/A	N/A	Clear Space to XWalk (in)	N/A
Yes	Any Obstructions?	No	Yes	Storm Grate/Utility Hazard?	No
	Obstruction Type			Storm Grate/Utility Type	
		N/A			N/A
			Yes	Surface Condition? (G/P)	Good

Possible Solutions:

**Remove & Replace Entire Ramp.
Grind Gutter Lip.**
