Access Compliance Report Public Rights-of-Way (Curb Ramps)

Intersection ID: 10032672 Main Street: N_KINGS_DR Cross Street: N/A Location: S

ADA ID: 3221CA4BB3DC Ramp Type: PerpDiag Initial Pass/Fail: Fail Overall Compliance: No Severity Score: 8.75

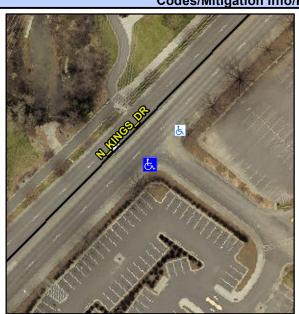
Not Found, R304.5.1

| Field Measurements/Component Compliance | | | | | | |
|---|---|---|---|---|---|---|
| | No | Ramp Width (in) | 44.0 | Yes | Ramp XSlope (%) | 0.3 |

Remove & Replace Curb Ramp With Two New Directional Ramps or Equivalent.

Total Cost: \$ 3200.00
