Access Compliance Report

Public Rights-of-Way

(Curb Ramps)

Intersection ID: 46196	Main Street: FERNSPRAY_RD	Cross Street: LUSTRE_RD	Location:	SE
ADA ID: 3232EA819F57	Ramp Type: PerpDiag	Initial Pass/Fail: Fail	Overall Compliance: No	Severity Score: 10
Codes/Mitigation Info/Possible Solution		Field Measurements/Component Compliance

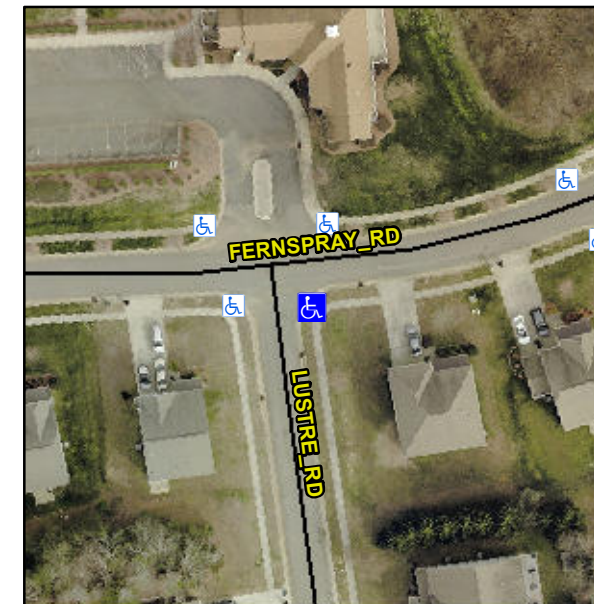
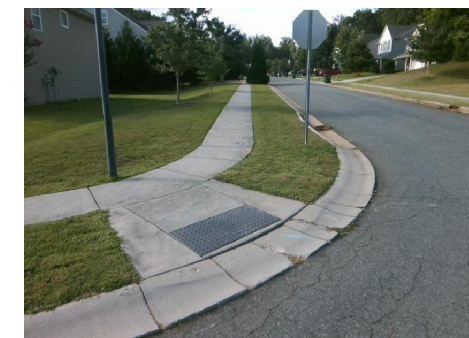
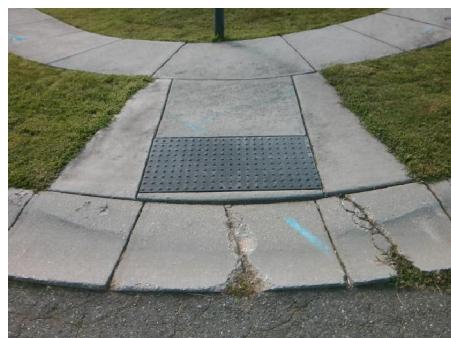
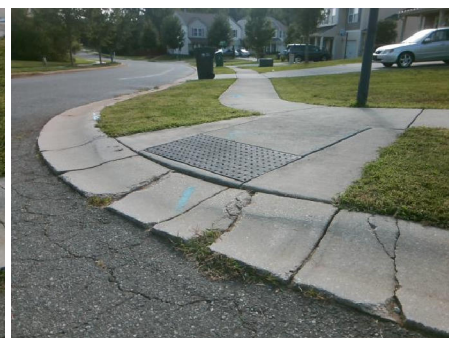
Not Found, R304.5.1, R304.5.3

Compliance	Description	Data	Compliance	Description	Data
N/A	Ramp Length (in)	70.0	Yes	Ramp Slope (%)	7.1
No	Ramp Width (in)	47.5	No	Ramp XSlope (%)	3.8
N/A	Flare Type LT	N/A	N/A	Flare Type RT	N/A
N/A	Flare Slope LT (%)	N/A	N/A	Flare Slope RT (%)	N/A
N/A	Flare Traversable LT?	N/A	N/A	Flare Traversable RT?	N/A
N/A	Landing Length (in)	N/A	N/A	DWS Provided?	N/A
N/A	Landing Width (in)	N/A	N/A	DWS Contrast?	N/A
N/A	Landing Slope (%)	N/A	N/A	DWS Length (in)	N/A
N/A	Landing X Slope (%)	N/A	N/A	DWS Full Width?	N/A
N/A	Landing Curb? (Y/N)	N/A	N/A	DWS Offset (in)	N/A
N/A	Shared Landing?	N/A			
N/A	Gutter Ponding?	N/A	N/A	Gutter Slope (%)	N/A
N/A	Gutter Lip Ht (in)	1.0	N/A	Gutter X Slope (%)	N/A
N/A	Painted X Walk1?	No	N/A	Painted X Walk2?	No
	X Walk 1 Direction	To W		X Walk 2 Direction	To N
N/A	X Walk 1 Width (in)	N/A	N/A	X Walk 2 Width (in)	N/A
	X Walk 1 Slope (%)	1.8		X Walk 2 Slope (%)	5.7
	X Walk 1 X Slope (%)	2.4		X Walk 2 X Slope (%)	0.6

N/A	Ramp inside XWalk1?	N/A	N/A	Ramp inside XWalk2?	N/A
	Road Slope (%)	3.0	N/A	Clear Space?	N/A
	Road X Slope (%)	2.7	N/A	Clear Space to XWalk (in)	N/A
N/A	Any Obstructions?	N/A	N/A	Storm Grate/Utility Hazard?	N/A
	Obstruction Type			Storm Grate/Utility Type	
		N/A			N/A
			Yes	Surface Condition? (G/P)	Good

Possible Solutions:

Remove & Replace Curb Ramp With Two New Directional Ramps or Equivalent.
