Access Compliance Report

Public Rights-of-Way

(Curb Ramps)

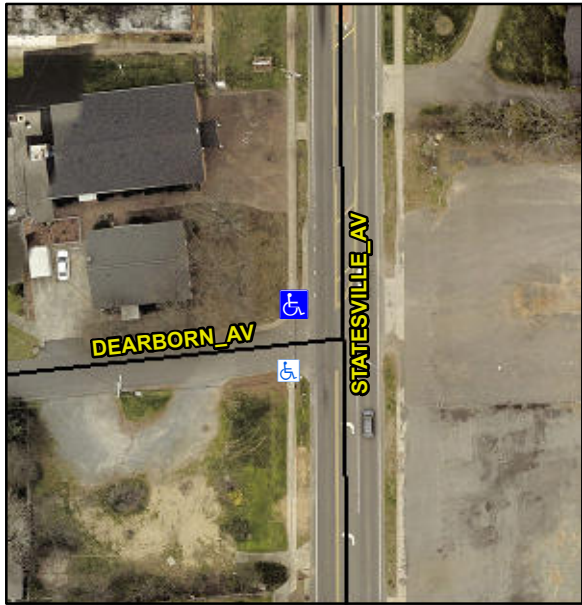
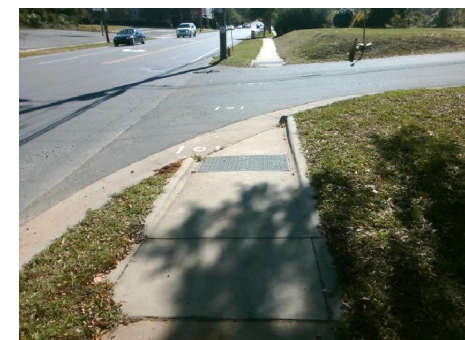
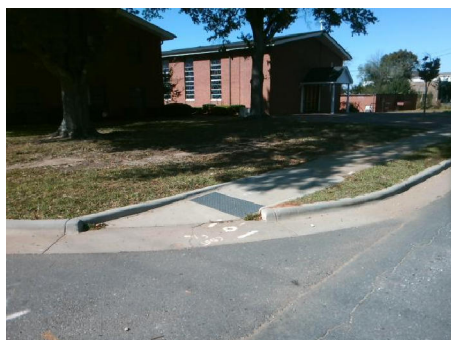
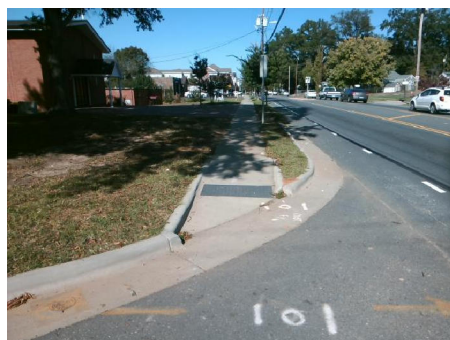
Intersection ID: 9380	Main Street: STATESVILLE_AV	Cross Street: DEARBORN_AV	Location: NW
ADA ID: 32423B53CB3D	Ramp Type: BlendTrans1	Initial Pass/Fail: Fail	Overall Compliance: No
Severity Score: 1.25			
Codes/Mitigation Info/Possible Solution		Field Measurements/Component Compliance

Possible Solutions:		Compliance		Description	Data	Compliance		Description	Data
	Remove & Replace Curb Ramp With Two New Directional Ramps or Equivalent.		N/A	Ramp Length (in)	122.0	Yes	BlendTrans Slope (%)	2.7		
			Yes	Ramp Width (in)	55.5	No	BlendTrans XSlope (%)	2.5		
			N/A	Flare Type LT	N/A	N/A	Flare Type RT	N/A		
			N/A	Flare Slope LT (%)	N/A	N/A	Flare Slope RT (%)	N/A		
			N/A	Flare Traversable LT?	N/A	N/A	Flare Traversable RT?	N/A		
			N/A	Landing Length (in)	N/A	N/A	DWS Provided?	N/A		
			N/A	Landing Width (in)	N/A	N/A	DWS Contrast?	N/A		
			N/A	Landing Slope (%)	N/A	N/A	DWS Length (in)	N/A		
			N/A	Landing X Slope (%)	N/A	N/A	DWS Full Width?	N/A		
Surveyor Notes: N/A PROW/ADA: R304.5.3			N/A	Landing Curb? (Y/N)	N/A	N/A	DWS Offset (in)	N/A		
			N/A	Shared Landing?	N/A					
			N/A	Gutter Ponding?	N/A	N/A	Gutter Slope (%)	N/A		
			N/A	Gutter Lip Ht (in)	N/A	N/A	Gutter X Slope (%)	N/A		
			N/A	Painted X Walk1?	No	N/A	Painted X Walk2?	N/A

X Walk 1 Direction	To S		X Walk 2 Direction	N/A		
				X Walk 1 Width (in)	N/A		X Walk 2 Width (in)	N/A		
				X Walk 1 Slope (%)	0.3		X Walk 2 Slope (%)	N/A		
				X Walk 1 X Slope (%)	2.3		X Walk 2 X Slope (%)	N/A		
			N/A	Ramp inside XWalk1?	N/A	N/A	Ramp inside XWalk2?	N/A		
Street 1 Name DEARBORN AV Stop Condition-Street 1 StopSign Street 2 Name N/A Stop Condition-Street 2 N/A				Road Slope (%)	2.3		Clear Space?	N/A		
				Road X Slope (%)	0.3	N/A	Clear Space to XWalk (in)	N/A		
			N/A	Any Obstructions?	N/A	N/A	Storm Grate/Utility Hazard?	N/A		
				Obstruction Type			Storm Grate/Utility Type			
						N/A		N/A		
						Yes	Surface Condition? (G/P)	Good		
						N/A	Curb Slope (%)	0.7
