Access Compliance Report

Public Rights-of-Way

(Curb Ramps)

Intersection ID: 12517	Main Street: N_SHARON_AMITY_RD	Cross Street: SHAMROCK_DR	Location:	E
ADA ID: 324F08921B7C	Ramp Type: Perp	Initial Pass/Fail: Fail	Overall Compliance: No	Severity Score: 12.5
Codes/Mitigation Info/Possible Solution		Field Measurements/Component Compliance

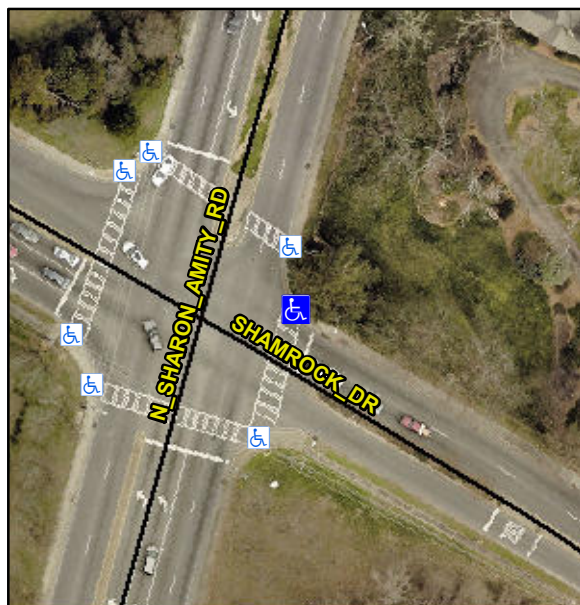
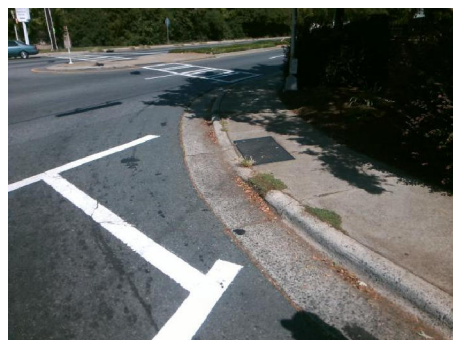
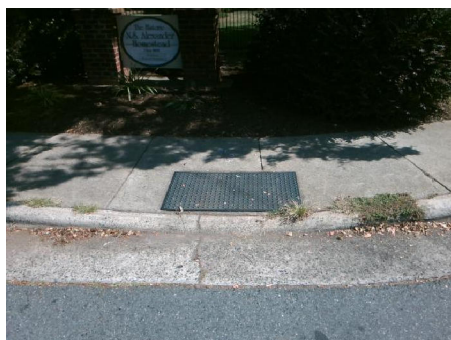
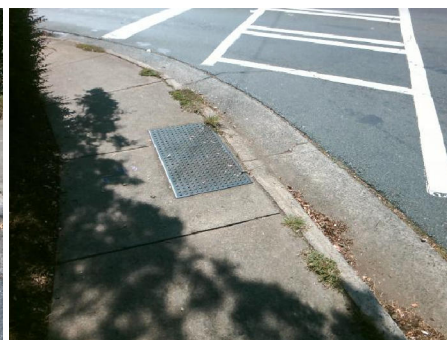
Not Found, R304.2.2

Compliance	Description	Data	Compliance	Description	Data
N/A	Ramp Length (in)	59.5	No	Ramp Slope (%)	9.3
Yes	Ramp Width (in)	48.0	Yes	Ramp XSlope (%)	0.1
N/A	Flare Type LT	N/A	N/A	Flare Type RT	N/A
N/A	Flare Slope LT (%)	N/A	N/A	Flare Slope RT (%)	N/A
N/A	Flare Traversable LT?	N/A	N/A	Flare Traversable RT?	N/A
N/A	Landing Length (in)	N/A	N/A	DWS Provided?	N/A
N/A	Landing Width (in)	N/A	N/A	DWS Contrast?	N/A
N/A	Landing Slope (%)	N/A	N/A	DWS Length (in)	N/A
N/A	Landing X Slope (%)	N/A	N/A	DWS Full Width?	N/A
N/A	Landing Curb? (Y/N)	N/A	N/A	DWS Offset (in)	N/A
N/A	Shared Landing?	N/A			
N/A	Gutter Ponding?	N/A	N/A	Gutter Slope (%)	N/A
N/A	Gutter Lip Ht (in)	N/A	N/A	Gutter X Slope (%)	N/A
N/A	Painted X Walk1?	Yes	N/A	Painted X Walk2?	N/A
	X Walk 1 Direction	To SW		X Walk 2 Direction	N/A
N/A	X Walk 1 Width (in)	117.5	N/A	X Walk 2 Width (in)	N/A
	X Walk 1 Slope (%)	0.2		X Walk 2 Slope (%)	N/A
	X Walk 1 X Slope (%)	1.1		X Walk 2 X Slope (%)	N/A

N/A	Ramp inside XWalk1?	Yes	N/A	Ramp inside XWalk2?	N/A
	Road Slope (%)	N/A	N/A	Clear Space?	N/A
	Road X Slope (%)	N/A	N/A	Clear Space to XWalk (in)	N/A
N/A	Any Obstructions?	N/A	N/A	Storm Grate/Utility Hazard?	N/A
	Obstruction Type			Storm Grate/Utility Type	
		N/A			N/A
			Yes	Surface Condition? (G/P)	Good

Remove & Replace Entire Ramp.
