# Access Compliance Report

## Public Rights-of-Way

### (Curb Ramps)

Intersection ID: 10024823	Main Street: DEMOCRACY_DR	Cross Street: N/A	Location: SW
ADA ID: 3251F867B518	Ramp Type: PerpDiag	Initial Pass/Fail: Fail	Overall Compliance: No
			Severity Score: 33.75

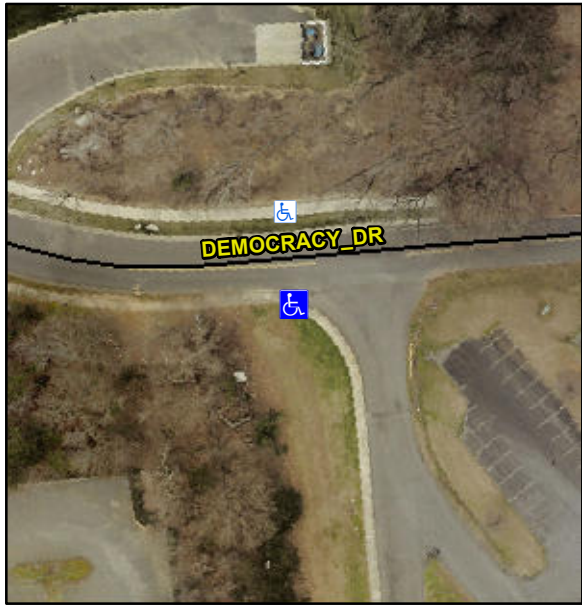
Possible Solutions:		Compliance	Description	Data	Compliance	Description	Data
	Remove & Replace Curb Ramp With Two New Directional Ramps or Equivalent.		N/A	Ramp Length (in)	63.0	No	Ramp Slope (%)	9.2
			No	Ramp Width (in)	45.0	No	Ramp XSlope (%)	6.3
			N/A	Flare Type LT	N/A	N/A	Flare Type RT	N/A
			N/A	Flare Slope LT (%)	N/A	N/A	Flare Slope RT (%)	N/A
			N/A	Flare Traversable LT?	N/A	N/A	Flare Traversable RT?	N/A
			N/A	Landing Length (in)	N/A	N/A	DWS Provided?	N/A
			N/A	Landing Width (in)	N/A	N/A	DWS Contrast?	N/A
			N/A	Landing Slope (%)	N/A	N/A	DWS Length (in)	N/A
			N/A	Landing X Slope (%)	N/A	N/A	DWS Full Width?	N/A
Surveyor Notes:		N/A	N/A	Landing Curb? (Y/N)	N/A	N/A	DWS Offset (in)	N/A
			N/A	Shared Landing?	N/A			
PROW/ADA:			N/A	Gutter Ponding?	N/A	N/A	Gutter Slope (%)	N/A
		R304.5.1, R304.2.2, R304.5.3	N/A	Gutter Lip Ht (in)	N/A	N/A	Gutter X Slope (%)	N/A

N/A	Painted X Walk1?	No	N/A	Painted X Walk2?	No
				X Walk 1 Direction	To E		X Walk 2 Direction	To N
			N/A	X Walk 1 Width (in)	N/A	N/A	X Walk 2 Width (in)	N/A
				X Walk 1 Slope (%)	7.2		X Walk 2 Slope (%)	0.1
				X Walk 1 X Slope (%)	0.3		X Walk 2 X Slope (%)	5.6
			N/A	Ramp inside XWalk1?	N/A	N/A	Ramp inside XWalk2?	N/A
				Road Slope (%)	6.2	N/A	Clear Space?	N/A
				Road X Slope (%)	2.9	N/A	Clear Space to XWalk (in)	N/A
			N/A	Any Obstructions?	N/A	N/A	Storm Grate/Utility Hazard?	N/A
				Obstruction Type			Storm Grate/Utility Type	
					N/A			N/A
						Yes	Surface Condition? (G/P)	Good
Street 1 Name		ENTRANCE						
Stop Condition-Street 2		StopSign						
Street 2 Name		DEMOCRACY DR						
Stop Condition-Street 1		None						
Total Cost:		\$ 3200.00
