Access Compliance Report Public Rights-of-Way (Curb Ramps)

Intersection ID: 13382 Main Street: E_CATHERINE_ST **Cross Street: S COLLEGE ST** Location:

ADA ID: 3254F2CB2A1B Ramp Type: PerpDiag Initial Pass/Fail: Fail **Overall Compliance: No** Severity Score: 26.25

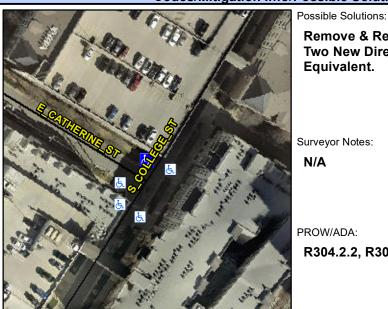
E CATHERINE ST Street 1 Name Stop Condition-Street 2 StopSign Street 2 Name S COLLEGE ST Stop Condition-Street 1 None

Cor	npliance Description	Data	Com	pliance Description	Data
N/A	Ramp Length (in)	104.0	No	Ramp Slope (%)	13.5
Yes	Ramp Width (in)	48.0	No	Ramp XSlope (%)	2.2
N/A	Flare Type LT	N/A	N/A	Flare Type RT	N/A
N/A	Flare Slope LT (%)	N/A	N/A	Flare Slope RT (%)	N/A
N/A	Flare Traversable LT?	N/A	N/A	Flare Traversable RT?	N/A
N/A	Landing Length (in)	N/A	N/A	DWS Provided?	N/A
N/A	Landing Width (in)	N/A	N/A	DWS Contrast?	N/A
N/A	Landing Slope (%)	N/A	N/A	DWS Length (in)	N/A
N/A	Landing X Slope (%)	N/A	N/A	DWS Full Width?	N/A
N/A	Landing Curb? (Y/N)	N/A	N/A	DWS Offset (in)	N/A
N/A	Shared Landing?	N/A			
N/A	Gutter Ponding?	N/A	N/A	Gutter Slope (%)	N/A
N/A	Gutter Lip Ht (in)	N/A	N/A	Gutter X Slope (%)	N/A
N/A	Painted X Walk1?	No	N/A	Painted X Walk2?	No
	X Walk 1 Direction	To SW		X Walk 2 Direction	To SE
N/A	X Walk 1 Width (in)	N/A	N/A	X Walk 2 Width (in)	N/A
	X Walk 1 Slope (%)	3.8		X Walk 2 Slope (%)	0.7
	X Walk 1 X Slope (%)	3.2		X Walk 2 X Slope (%)	1.3

N/A	Ramp inside XWalk1?	N/A	N/A	Ramp inside XWalk2?	N/A
	Road Slope (%)	1.2	N/A	Clear Space?	N/A
	Road X Slope (%)	3.3	N/A	Clear Space to XWalk (in)	N/A
N/A	Any Obstructions?	N/A	N/A	Storm Grate/Utility Hazard?	N/A
	Obstruction Type			Storm Grate/Utility Type	
		N/A			N/A

Remove & Replace Curb Ramp With Two New Directional Ramps or Equivalent.

R304.2.2, R304.5.3
