Access Compliance Report

Public Rights-of-Way

(Curb Ramps)

Intersection ID: 23730	Main Street: PROVIDENCE_RD	Cross Street: CEDAR_CROFT_DR	Location: SE
ADA ID: 32572F8A41C7	Ramp Type: Perp	Initial Pass/Fail: Fail	Overall Compliance: No
Severity Score: 21.25			
Codes/Mitigation Info/Possible Solution		Field Measurements/Component Compliance

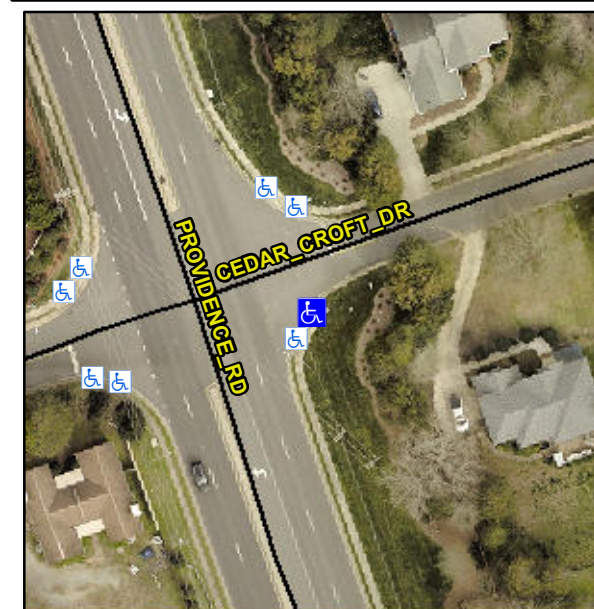
Compliance	Description	Data	Compliance	Description	Data
N/A	Ramp Length (in)	60.0	No	Ramp Slope (%)	10.6
No	Ramp Width (in)	42.0	Yes	Ramp XSlope (%)	1.4
N/A	Flare Type LT	N/A	N/A	Flare Type RT	N/A
N/A	Flare Slope LT (%)	N/A	N/A	Flare Slope RT (%)	N/A
N/A	Flare Traversable LT?	N/A	N/A	Flare Traversable RT?	N/A
N/A	Landing Length (in)	N/A	N/A	DWS Provided?	N/A
N/A	Landing Width (in)	N/A	N/A	DWS Contrast?	N/A
N/A	Landing Slope (%)	N/A	N/A	DWS Length (in)	N/A
N/A	Landing X Slope (%)	N/A	N/A	DWS Full Width?	N/A
N/A	Landing Curb? (Y/N)	N/A	N/A	DWS Offset (in)	N/A
N/A	Shared Landing?	N/A			
N/A	Gutter Ponding?	N/A	N/A	Gutter Slope (%)	N/A
N/A	Gutter Lip Ht (in)	N/A	N/A	Gutter X Slope (%)	N/A
N/A	Painted X Walk1?	No	N/A	Painted X Walk2?	N/A
	X Walk 1 Direction	To N		X Walk 2 Direction	N/A
N/A	X Walk 1 Width (in)	N/A	N/A	X Walk 2 Width (in)	N/A
	X Walk 1 Slope (%)	5.4		X Walk 2 Slope (%)	N/A
	X Walk 1 X Slope (%)	3.5		X Walk 2 X Slope (%)	N/A

N/A	Ramp inside XWalk1?	N/A	N/A	Ramp inside XWalk2?	N/A
	Road Slope (%)	N/A	N/A	Clear Space?	N/A
	Road X Slope (%)	N/A	N/A	Clear Space to XWalk (in)	N/A
N/A	Any Obstructions?	N/A	N/A	Storm Grate/Utility Hazard?	N/A
	Obstruction Type			Storm Grate/Utility Type	
		N/A			N/A
		Yes		Surface Condition? (G/P)	Good

Possible Solutions:

Remove & Replace Entire Ramp.

R304.5.1, R304.2.2
