Access Compliance Report

Public Rights-of-Way

(Curb Ramps)

Intersection ID: 18408	Main Street: REDCOAT_DR	Cross Street: LYNBROOK_DR	Location: SW
ADA ID: 32581AC9F950	Ramp Type: PerpDiag	Initial Pass/Fail: Fail	Overall Compliance: No
Severity Score: 12.5			
Codes/Mitigation Info/Possible Solution		Field Measurements/Component Compliance

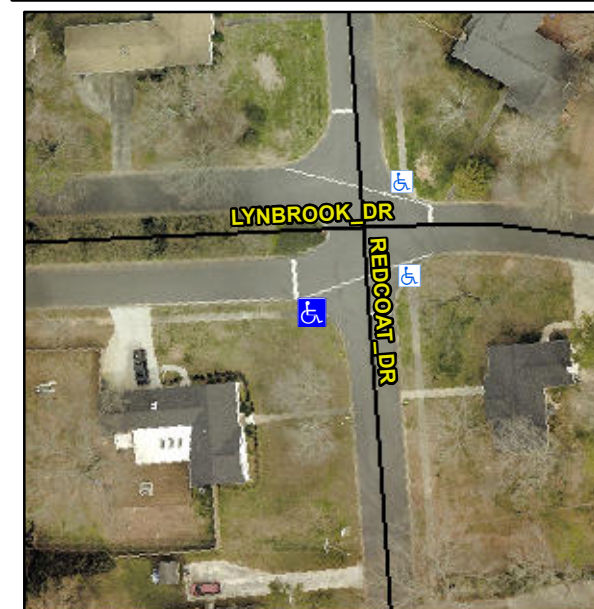
Not Found, R304.2.2

Compliance	Description	Data	Compliance	Description	Data
N/A	Ramp Length (in)	32.0	No	Ramp Slope (%)	8.5
Yes	Ramp Width (in)	48.0	Yes	Ramp XSlope (%)	0.2
N/A	Flare Type LT	N/A	N/A	Flare Type RT	N/A
N/A	Flare Slope LT (%)	N/A	N/A	Flare Slope RT (%)	N/A
N/A	Flare Traversable LT?	N/A	N/A	Flare Traversable RT?	N/A
N/A	Landing Length (in)	N/A	N/A	DWS Provided?	N/A
N/A	Landing Width (in)	N/A	N/A	DWS Contrast?	N/A
N/A	Landing Slope (%)	N/A	N/A	DWS Length (in)	N/A
N/A	Landing X Slope (%)	N/A	N/A	DWS Full Width?	N/A
N/A	Landing Curb? (Y/N)	N/A	N/A	DWS Offset (in)	N/A
N/A	Shared Landing?	N/A			
N/A	Gutter Ponding?	N/A	N/A	Gutter Slope (%)	N/A
N/A	Gutter Lip Ht (in)	N/A	N/A	Gutter X Slope (%)	N/A
N/A	Painted X Walk1?	No	N/A	Painted X Walk2?	No
	X Walk 1 Direction	To E		X Walk 2 Direction	To N
N/A	X Walk 1 Width (in)	N/A	N/A	X Walk 2 Width (in)	N/A
	X Walk 1 Slope (%)	2.6		X Walk 2 Slope (%)	3.6
	X Walk 1 X Slope (%)	4.1		X Walk 2 X Slope (%)	2.3

N/A	Ramp inside XWalk1?	N/A	N/A	Ramp inside XWalk2?	N/A
	Road Slope (%)	0.6	N/A	Clear Space?	N/A
	Road X Slope (%)	3.9	N/A	Clear Space to XWalk (in)	N/A
N/A	Any Obstructions?	N/A	N/A	Storm Grate/Utility Hazard?	N/A
	Obstruction Type			Storm Grate/Utility Type	
		N/A			N/A
		Yes		Surface Condition? (G/P)	Good

Remove & Replace Curb Ramp With Two New Directional Ramps or Equivalent.
