Access Compliance Report

Public Rights-of-Way

(Curb Ramps)

Intersection ID: 12438	Main Street: E_8TH_ST	Cross Street: N_DAVIDSON_ST	Location: S
ADA ID: 32609EC1AF80	Ramp Type: BlendTrans1	Initial Pass/Fail: Fail	Overall Compliance: No
Severity Score: 8.75			
Codes/Mitigation Info/Possible Solution		Field Measurements/Component Compliance

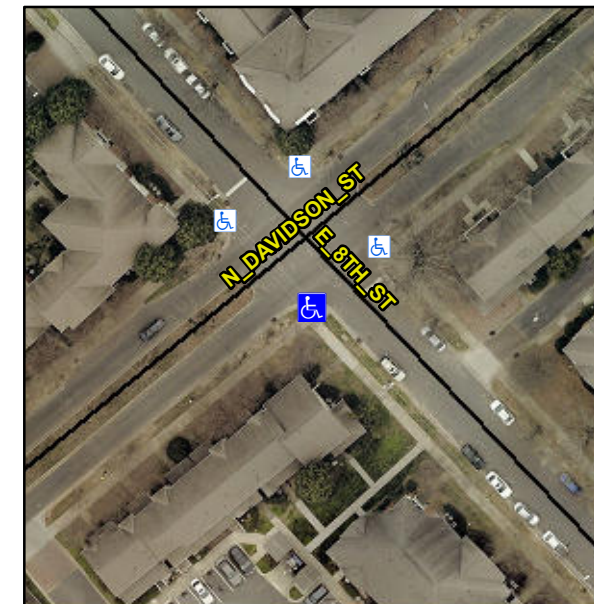
Compliance	Description	Data	Compliance	Description	Data
N/A	Ramp Length (in)	70.0	Yes	BlendTrans Slope (%)	4.1
No	Ramp Width (in)	36.5	Yes	BlendTrans XSlope (%)	0.0
N/A	Flare Type LT	N/A	N/A	Flare Type RT	N/A
N/A	Flare Slope LT (%)	N/A	N/A	Flare Slope RT (%)	N/A
N/A	Flare Traversable LT?	N/A	N/A	Flare Traversable RT?	N/A
N/A	Landing Length (in)	N/A	N/A	DWS Provided?	N/A
N/A	Landing Width (in)	N/A	N/A	DWS Contrast?	N/A
N/A	Landing Slope (%)	N/A	N/A	DWS Length (in)	N/A
N/A	Landing X Slope (%)	N/A	N/A	DWS Full Width?	N/A
N/A	Landing Curb? (Y/N)	N/A	N/A	DWS Offset (in)	N/A
N/A	Shared Landing?	N/A			
N/A	Gutter Ponding?	N/A	N/A	Gutter Slope (%)	N/A
N/A	Gutter Lip Ht (in)	N/A	N/A	Gutter X Slope (%)	N/A
N/A	Painted X Walk1?	No	N/A	Painted X Walk2?	No
	X Walk 1 Direction	To NE		X Walk 2 Direction	To NW
	X Walk 1 Width (in)	N/A		X Walk 2 Width (in)	N/A
	X Walk 1 Slope (%)	4.5		X Walk 2 Slope (%)	2.8
	X Walk 1 X Slope (%)	1.4		X Walk 2 X Slope (%)	0.5

N/A	Ramp inside XWalk1?	N/A	N/A	Ramp inside XWalk2?	N/A
	Road Slope (%)	1.4		Clear Space?	N/A
	Road X Slope (%)	1.9	N/A	Clear Space to XWalk (in)	N/A
N/A	Any Obstructions?	N/A	N/A	Storm Grate/Utility Hazard?	N/A
	Obstruction Type			Storm Grate/Utility Type	
		N/A			N/A
			Yes	Surface Condition? (G/P)	Good
			No	Curb Slope (%)	16.5

Possible Solutions:

Remove & Replace Curb Ramp With Two New Directional Ramps or Equivalent.

PROW/ADA:

Not Found, R304.5.1

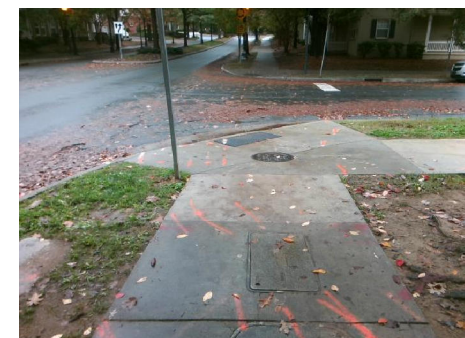
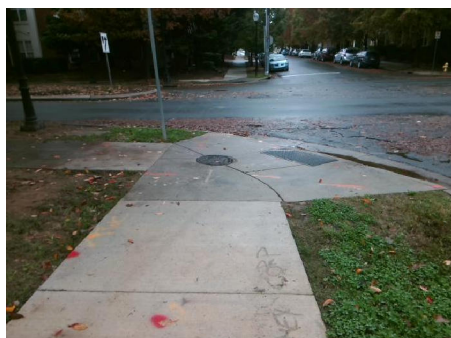
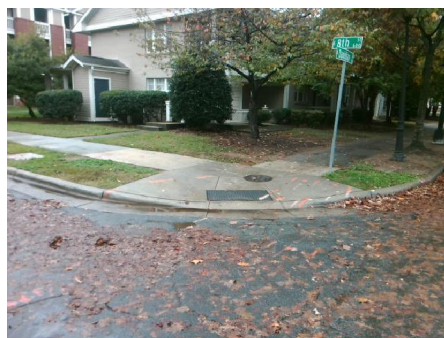
Street 1 Name E 8TH ST
 Stop Condition-Street 1 StopSign
 Street 2 Name N DAVIDSON ST
 Stop Condition-Street 2 None
