Access Compliance Report

Public Rights-of-Way (Curb Ramps)

Intersection ID: 52926	Main Street: WALTHAM_LN	Cross Street: EMORY_OAK_DR	Location: NW
ADA ID: 326B1CC36165	Ramp Type: BlendTrans1	Initial Pass/Fail: Fail	Overall Compliance: No
Severity Score: 8.75			
Codes/Mitigation Info/Possible Solution		Field Measurements/Component Compliance

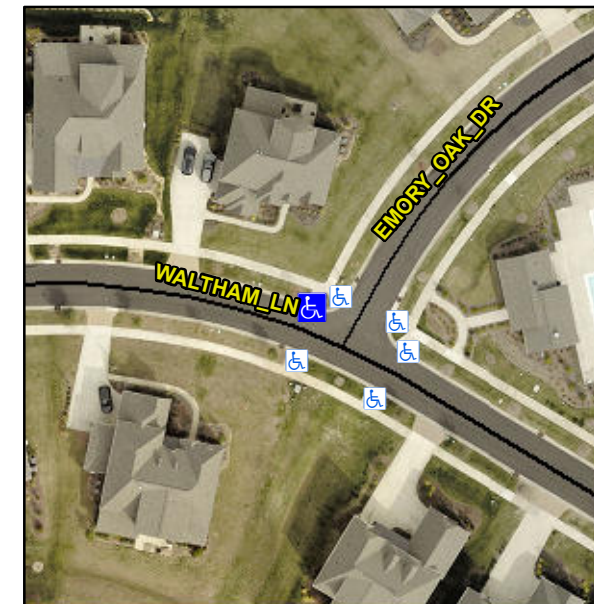
Not Found, R304.5.1

Compliance	Description	Data	Compliance	Description	Data
N/A	Ramp Length (in)	92.0	Yes	BlendTrans Slope (%)	3.9
No	Ramp Width (in)	47.5	Yes	BlendTrans XSlope (%)	1.8
N/A	Flare Type LT	N/A	N/A	Flare Type RT	N/A
N/A	Flare Slope LT (%)	N/A	N/A	Flare Slope RT (%)	N/A
N/A	Flare Traversable LT?	N/A	N/A	Flare Traversable RT?	N/A
N/A	Landing Length (in)	N/A	N/A	DWS Provided?	N/A
N/A	Landing Width (in)	N/A	N/A	DWS Contrast?	N/A
N/A	Landing Slope (%)	N/A	N/A	DWS Length (in)	N/A
N/A	Landing X Slope (%)	N/A	N/A	DWS Full Width?	N/A
N/A	Landing Curb? (Y/N)	N/A	N/A	DWS Offset (in)	N/A
N/A	Shared Landing?	N/A			
N/A	Gutter Ponding?	N/A	N/A	Gutter Slope (%)	N/A
N/A	Gutter Lip Ht (in)	N/A	N/A	Gutter X Slope (%)	N/A
N/A	Painted X Walk1?	No	N/A	Painted X Walk2?	N/A
	X Walk 1 Direction	To S		X Walk 2 Direction	N/A
	X Walk 1 Width (in)	N/A		X Walk 2 Width (in)	N/A
	X Walk 1 Slope (%)	3.9		X Walk 2 Slope (%)	N/A
	X Walk 1 X Slope (%)	2.4		X Walk 2 X Slope (%)	N/A

N/A	Ramp inside XWalk1?	N/A	N/A	Ramp inside XWalk2?	N/A
	Road Slope (%)	2.4		Clear Space?	N/A
	Road X Slope (%)	3.9	N/A	Clear Space to XWalk (in)	N/A
N/A	Any Obstructions?	N/A	N/A	Storm Grate/Utility Hazard?	N/A
	Obstruction Type			Storm Grate/Utility Type	
		N/A			N/A
			Yes	Surface Condition? (G/P)	Good
			No	Curb Slope (%)	7.3

Remove & Replace Curb Ramp With Two New Directional Ramps or Equivalent.
