Access Compliance Report

Public Rights-of-Way

(Curb Ramps)

Intersection ID: 10015045	Main Street: CARLEEN_WAY_DR	Cross Street: N/A	Location: W
ADA ID: 3277EF766CB6	Ramp Type: PerpDiag	Initial Pass/Fail: Fail	Overall Compliance: No
			Severity Score: 21.25

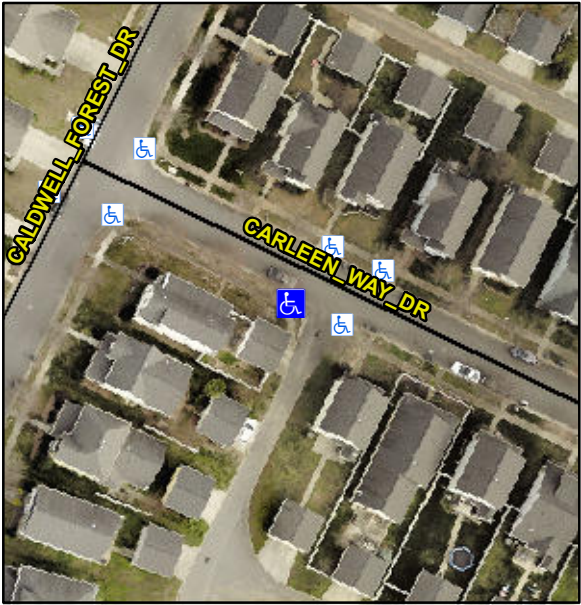
Possible Solutions:		Compliance	Description	Data
	Remove & Replace Curb Ramp With Two New Directional Ramps or Equivalent.		Yes	Ramp Length (in)	57.5
			No	Ramp Width (in)	43.0
			N/A	Flare Type LT	N/A
			N/A	Flare Slope LT (%)	N/A
			N/A	Flare Traversable LT?	N/A
			N/A	Landing Length (in)	N/A
			N/A	Landing Width (in)	N/A
			N/A	Landing Slope (%)	N/A
			N/A	Landing X Slope (%)	N/A
			N/A	Landing Curb? (Y/N)	N/A
			N/A	Shared Landing?	N/A
			N/A	Gutter Ponding?	N/A
			N/A	Gutter Lip Ht (in)	N/A
			No	Painted X Walk1?	N/A
				X Walk 1 Direction	To S
			N/A	X Walk 1 Width (in)	N/A
				X Walk 1 Slope (%)	10.2
				X Walk 1 X Slope (%)	0.4
			N/A	Ramp inside XWalk1?	N/A
<p>Surveyor Notes:</p> <p>N/A</p> <p>PROW/ADA:</p> <p>R304.5.1, R304.5.3</p>			N/A	Flare Type RT	N/A
			N/A	Flare Slope RT (%)	N/A
			N/A	Flare Traversable RT?	N/A

N/A	DWS Provided?	N/A
			N/A	DWS Contrast?	N/A
			N/A	DWS Length (in)	N/A
			N/A	DWS Full Width?	N/A
			N/A	DWS Offset (in)	N/A
			N/A	Gutter Slope (%)	N/A
			N/A	Gutter X Slope (%)	N/A
			No	Painted X Walk2?	N/A
				X Walk 2 Direction	To E
			N/A	X Walk 2 Width (in)	N/A
				X Walk 2 Slope (%)	4.7
				X Walk 2 X Slope (%)	7.1
			N/A	Ramp inside XWalk2?	N/A
			N/A	Clear Space?	N/A
			N/A	Clear Space to XWalk (in)	N/A
			N/A	Storm Grate/Utility Hazard?	N/A
				Storm Grate/Utility Type	N/A
<p>Total Cost:</p> <p>\$ 3200.00</p>			N/A	Surface Condition? (G/P)	Good
