# Access Compliance Report

## Public Rights-of-Way

### (Curb Ramps)

Intersection ID: 6085	Main Street: HARTLEY_HILLS_DR	Cross Street: WYNDHAM_POINTE_DR	Location: W
ADA ID: 32785BCBF7BA	Ramp Type: Perp	Initial Pass/Fail: Fail	Overall Compliance: No
Severity Score: 12.5			
Codes/Mitigation Info/Possible Solution		Field Measurements/Component Compliance

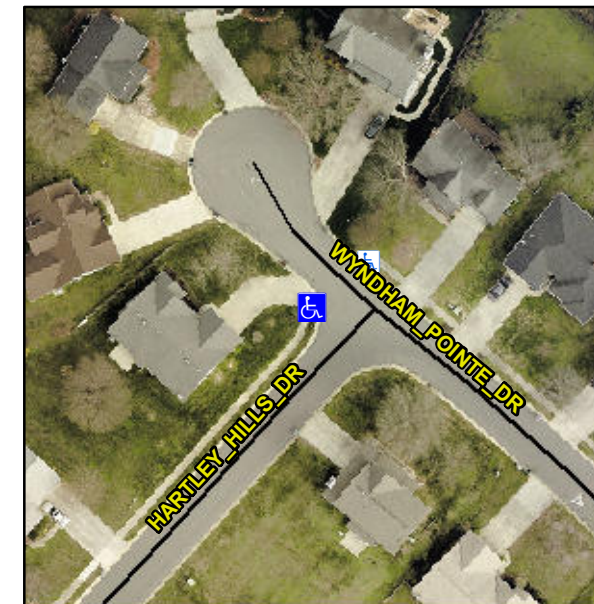
**Not Found, R304.5.3**

Compliance	Description	Data	Compliance	Description	Data
N/A	Ramp Length (in)	49.0	Yes	Ramp Slope (%)	5.2
Yes	Ramp Width (in)	49.0	No	Ramp XSlope (%)	5.8
N/A	Flare Type LT	N/A	N/A	Flare Type RT	N/A
N/A	Flare Slope LT (%)	N/A	N/A	Flare Slope RT (%)	N/A
N/A	Flare Traversable LT?	N/A	N/A	Flare Traversable RT?	N/A
N/A	Landing Length (in)	N/A	N/A	DWS Provided?	N/A
N/A	Landing Width (in)	N/A	N/A	DWS Contrast?	N/A
N/A	Landing Slope (%)	N/A	N/A	DWS Length (in)	N/A
N/A	Landing X Slope (%)	N/A	N/A	DWS Full Width?	N/A
N/A	Landing Curb? (Y/N)	N/A	N/A	DWS Offset (in)	N/A
N/A	Shared Landing?	N/A			
N/A	Gutter Ponding?	N/A	N/A	Gutter Slope (%)	N/A
N/A	Gutter Lip Ht (in)	N/A	N/A	Gutter X Slope (%)	N/A
N/A	Painted X Walk1?	No	N/A	Painted X Walk2?	N/A
	X Walk 1 Direction	To NE		X Walk 2 Direction	N/A
N/A	X Walk 1 Width (in)	N/A	N/A	X Walk 2 Width (in)	N/A
	X Walk 1 Slope (%)	1.4		X Walk 2 Slope (%)	N/A
	X Walk 1 X Slope (%)	5.9		X Walk 2 X Slope (%)	N/A

N/A	Ramp inside XWalk1?	N/A	N/A	Ramp inside XWalk2?	N/A
	Road Slope (%)	N/A	N/A	Clear Space?	N/A
	Road X Slope (%)	N/A	N/A	Clear Space to XWalk (in)	N/A
N/A	Any Obstructions?	N/A	N/A	Storm Grate/Utility Hazard?	N/A
	Obstruction Type			Storm Grate/Utility Type	
		N/A			N/A
		Yes		Surface Condition? (G/P)	Good

Possible Solutions:

**Remove & Replace Entire Ramp.**

Total Cost: \$ 1850.00
