Access Compliance Report

Public Rights-of-Way

(Curb Ramps)

Intersection ID: 28030	Main Street: CHEVIS_CT	Cross Street: LEGACY_CR	Location: NW
ADA ID: 328C3EB0EF77	Ramp Type: Perp	Initial Pass/Fail: Fail	Overall Compliance: No
Severity Score: 1.25			
Codes/Mitigation Info/Possible Solution		Field Measurements/Component Compliance

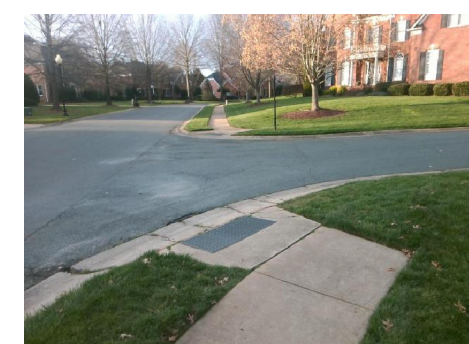
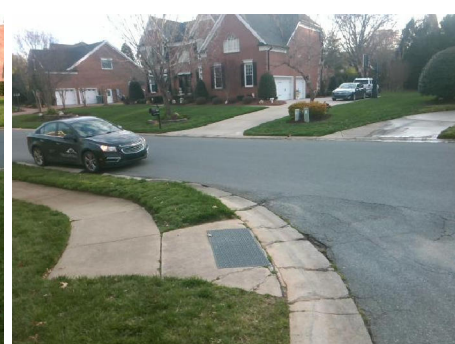
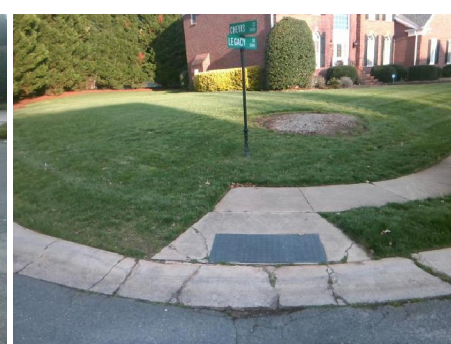
Not Found, R304.5.3

Compliance	Description	Data	Compliance	Description	Data
N/A	Ramp Length (in)	50.0	Yes	Ramp Slope (%)	6.3
Yes	Ramp Width (in)	48.0	No	Ramp XSlope (%)	4.1
N/A	Flare Type LT	N/A	N/A	Flare Type RT	N/A
N/A	Flare Slope LT (%)	N/A	N/A	Flare Slope RT (%)	N/A
N/A	Flare Traversable LT?	N/A	N/A	Flare Traversable RT?	N/A
N/A	Landing Length (in)	N/A	N/A	DWS Provided?	N/A
N/A	Landing Width (in)	N/A	N/A	DWS Contrast?	N/A
N/A	Landing Slope (%)	N/A	N/A	DWS Length (in)	N/A
N/A	Landing X Slope (%)	N/A	N/A	DWS Full Width?	N/A
N/A	Landing Curb? (Y/N)	N/A	N/A	DWS Offset (in)	N/A
N/A	Shared Landing?	N/A			
N/A	Gutter Ponding?	N/A	N/A	Gutter Slope (%)	N/A
N/A	Gutter Lip Ht (in)	N/A	N/A	Gutter X Slope (%)	N/A
N/A	Painted X Walk1?	No	N/A	Painted X Walk2?	N/A
	X Walk 1 Direction	To S		X Walk 2 Direction	N/A
N/A	X Walk 1 Width (in)	N/A	N/A	X Walk 2 Width (in)	N/A
	X Walk 1 Slope (%)	3.1		X Walk 2 Slope (%)	N/A
	X Walk 1 X Slope (%)	1.4		X Walk 2 X Slope (%)	N/A

N/A	Ramp inside XWalk1?	N/A	N/A	Ramp inside XWalk2?	N/A
	Road Slope (%)	N/A	N/A	Clear Space?	N/A
	Road X Slope (%)	N/A	N/A	Clear Space to XWalk (in)	N/A
N/A	Any Obstructions?	N/A	N/A	Storm Grate/Utility Hazard?	N/A
	Obstruction Type			Storm Grate/Utility Type	
		N/A			N/A
		Yes		Surface Condition? (G/P)	Good

Remove & Replace Entire Ramp.
