Access Compliance Report

Public Rights-of-Way

(Curb Ramps)

Intersection ID: 14213	Main Street: CENTRAL_AV	Cross Street: ROSEHAVEN_DR	Location: SE
ADA ID: 328C80955F4D	Ramp Type: BlendTrans1	Initial Pass/Fail: Fail	Overall Compliance: No
		Severity Score: 8.75	
Codes/Mitigation Info/Possible Solution		Field Measurements/Component Compliance

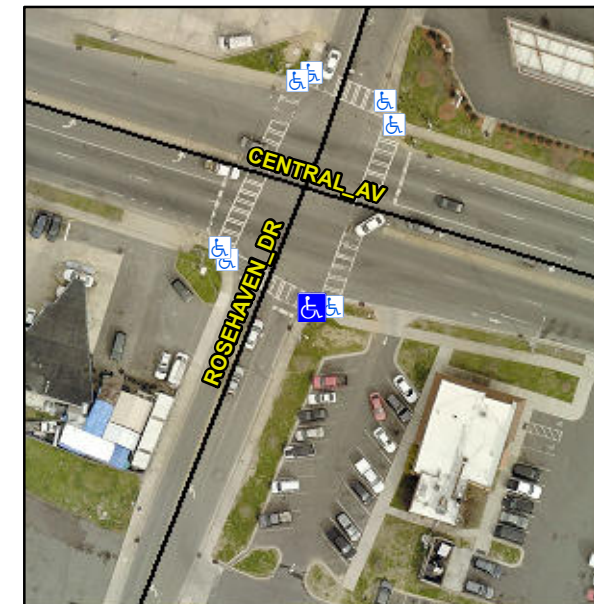
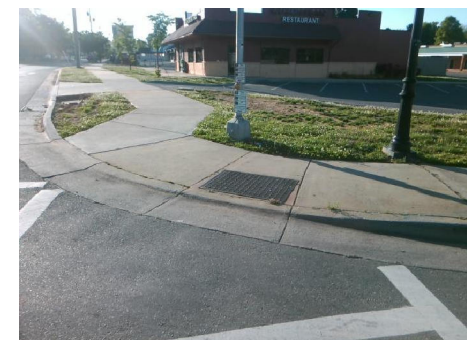
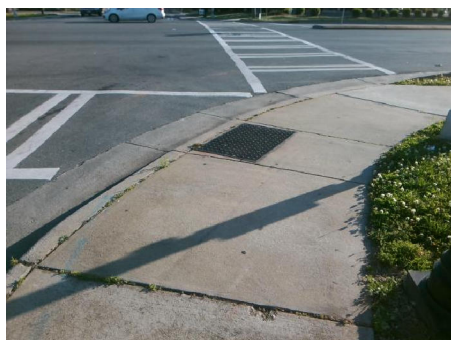
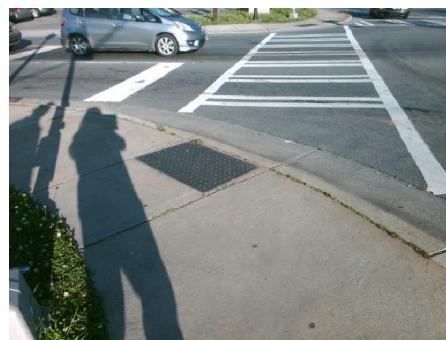
Not Found, R304.5.1

Compliance	Description	Data	Compliance	Description	Data
N/A	Ramp Length (in)	69.5	Yes	BlendTrans Slope (%)	2.1
No	Ramp Width (in)	37.5	Yes	BlendTrans XSlope (%)	2.0
N/A	Flare Type LT	N/A	N/A	Flare Type RT	N/A
N/A	Flare Slope LT (%)	N/A	N/A	Flare Slope RT (%)	N/A
N/A	Flare Traversable LT?	N/A	N/A	Flare Traversable RT?	N/A
N/A	Landing Length (in)	N/A	N/A	DWS Provided?	N/A
N/A	Landing Width (in)	N/A	N/A	DWS Contrast?	N/A
N/A	Landing Slope (%)	N/A	N/A	DWS Length (in)	N/A
N/A	Landing X Slope (%)	N/A	N/A	DWS Full Width?	N/A
N/A	Landing Curb? (Y/N)	N/A	N/A	DWS Offset (in)	N/A
N/A	Shared Landing?	N/A			
N/A	Gutter Ponding?	N/A	N/A	Gutter Slope (%)	N/A
N/A	Gutter Lip Ht (in)	N/A	N/A	Gutter X Slope (%)	N/A
N/A	Painted X Walk1?	Yes	N/A	Painted X Walk2?	N/A
	X Walk 1 Direction	To NW		X Walk 2 Direction	N/A
	X Walk 1 Width (in)	106.0		X Walk 2 Width (in)	N/A
	X Walk 1 Slope (%)	3.0		X Walk 2 Slope (%)	N/A
	X Walk 1 X Slope (%)	3.4		X Walk 2 X Slope (%)	N/A

N/A	Ramp inside XWalk1?	Yes	N/A	Ramp inside XWalk2?	N/A
	Road Slope (%)	3.4		Clear Space?	N/A
	Road X Slope (%)	3.0	N/A	Clear Space to XWalk (in)	N/A
N/A	Any Obstructions?	N/A	N/A	Storm Grate/Utility Hazard?	N/A
	Obstruction Type			Storm Grate/Utility Type	
		N/A			N/A
			Yes	Surface Condition? (G/P)	Good
			No	Curb Slope (%)	27.8

Possible Solutions:

Remove & Replace Curb Ramp With Two New Directional Ramps or Equivalent.
