Access Compliance Report

Public Rights-of-Way

(Curb Ramps)

Intersection ID: 46807	Main Street: ADLIN_AV	Cross Street: SWEET_BING_CT	Location: S
ADA ID: 328F02B7A57F	Ramp Type: Perp	Initial Pass/Fail: Pass	Overall Compliance: No
Severity Score: 17.5			
Codes/Mitigation Info/Possible Solution		Field Measurements/Component Compliance

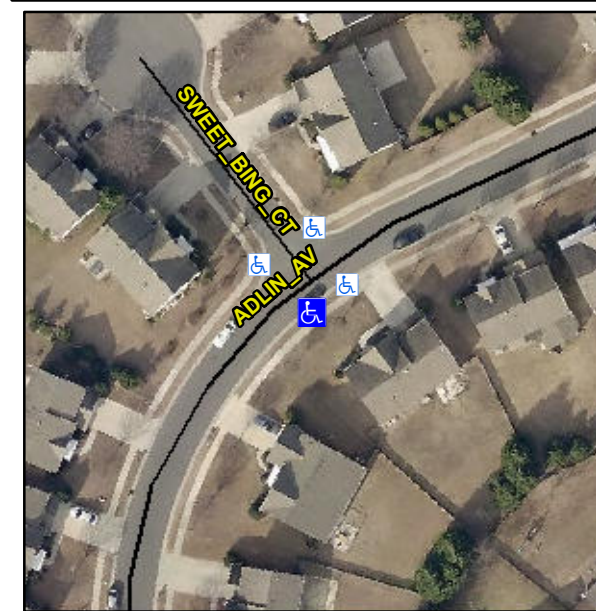
Not Found, R305, R302.7.2

Compliance	Description	Data	Compliance	Description	Data
N/A	Ramp Length (in)	47.0	Yes	Ramp Slope (%)	7.9
Yes	Ramp Width (in)	54.0	Yes	Ramp XSlope (%)	1.1
N/A	Flare Type LT	Sloped	N/A	Flare Type RT	N/A
N/A	Flare Slope LT (%)	6.4	Yes	Flare Slope RT (%)	7.1
N/A	Flare Traversable LT?	Yes	N/A	Flare Traversable RT?	Yes
Yes	Landing Length (in)	48.0	No	DWS Provided?	No
Yes	Landing Width (in)	54.0	N/A	DWS Contrast?	No
Yes	Landing Slope (%)	1.1	N/A	DWS Length (in)	N/A
Yes	Landing X Slope (%)	0.4	N/A	DWS Full Width?	No
N/A	Landing Curb? (Y/N)	No	N/A	DWS Offset (in)	N/A
N/A	Shared Landing?	No			
Yes	Gutter Ponding?	No	Yes	Gutter Slope (%)	1.8
No	Gutter Lip Ht (in)	0.5	Yes	Gutter X Slope (%)	0.1
N/A	Painted X Walk1?	No	N/A	Painted X Walk2?	N/A
	X Walk 1 Direction	To NW		X Walk 2 Direction	N/A
N/A	X Walk 1 Width (in)	N/A	N/A	X Walk 2 Width (in)	N/A
	X Walk 1 Slope (%)	3.7		X Walk 2 Slope (%)	N/A
	X Walk 1 X Slope (%)	0.3		X Walk 2 X Slope (%)	N/A

N/A	Ramp inside XWalk1?	N/A	N/A	Ramp inside XWalk2?	N/A
	Road Slope (%)	N/A	N/A	Clear Space?	Yes
	Road X Slope (%)	N/A	N/A	Clear Space to XWalk (in)	N/A
Yes	Any Obstructions?	No	Yes	Storm Grate/Utility Hazard?	No
	Obstruction Type			Storm Grate/Utility Type	
		N/A			N/A
			Yes	Surface Condition? (G/P)	Good

Possible Solutions:

Remove & Replace Entire Ramp.
