# Access Compliance Report

## Public Rights-of-Way

### (Curb Ramps)

| Intersection ID: 27468 | Main Street: BALLANTYNE COMMONS PY | Cross Street: JOHN J DELANEY DR | Location: SW |

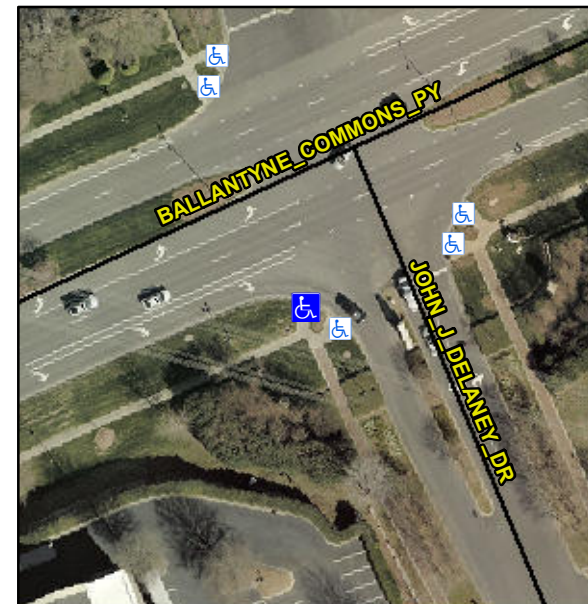
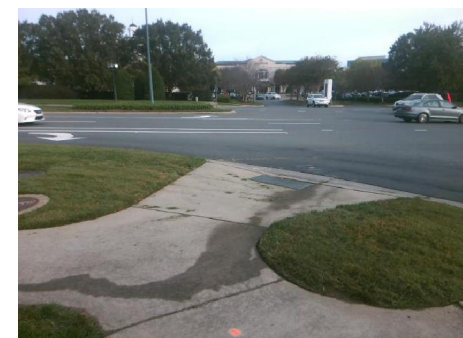
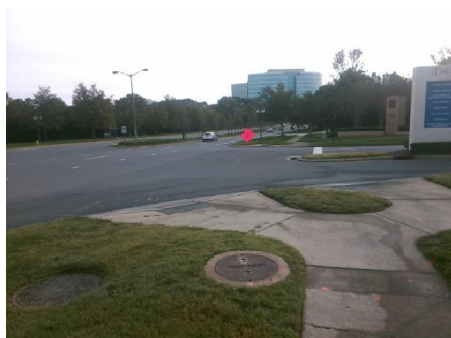
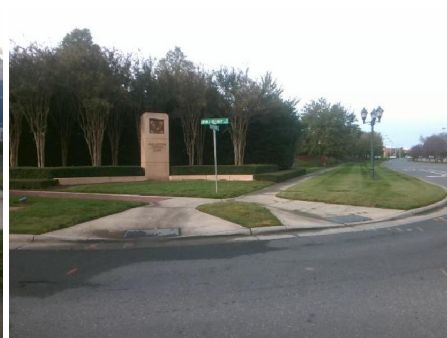
| ADA ID: 32988AAD7A45 | Ramp Type: Perp | Initial Pass/Fail: Fail | Overall Compliance: No |
| Severity Score: 13.75 | | | |

**R304.2.2, R304.5.3**

| Compliance | Description | Data | Compliance | Description | Data |
|---|---|---|---|---|---|
| N/A | Ramp Length (in) | <b>134.0</b> | No | Ramp Slope (%) | <b>8.7</b> |
| Yes | Ramp Width (in) | <b>48.0</b> | No | Ramp XSlope (%) | <b>2.7</b> |

**Remove & Replace Entire Ramp.**

Total Cost: \$ **1850.00**
