Access Compliance Report

Public Rights-of-Way

(Curb Ramps)

Intersection ID: 48630	Main Street: ISABEL_CT	Cross Street: WALKER_RD	Location: SW
ADA ID: 3299CE5E299A	Ramp Type: PerpDiag	Initial Pass/Fail: Fail	Overall Compliance: No
		Severity Score: 10

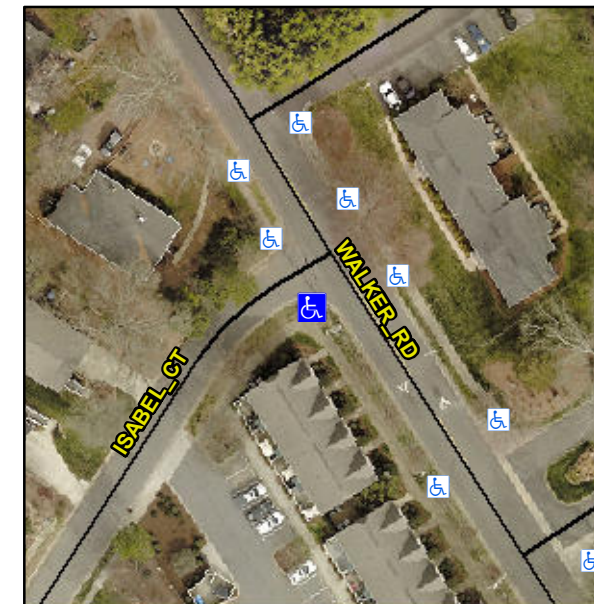
Not Found, R304.5.1, R304.5.3

Compliance	Description	Data	Compliance	Description	Data
N/A	Ramp Length (in)	97.0	Yes	Ramp Slope (%)	8.1
No	Ramp Width (in)	47.0	No	Ramp XSlope (%)	4.2
N/A	Flare Type LT	N/A	N/A	Flare Type RT	N/A
N/A	Flare Slope LT (%)	N/A	N/A	Flare Slope RT (%)	N/A
N/A	Flare Traversable LT?	N/A	N/A	Flare Traversable RT?	N/A
N/A	Landing Length (in)	N/A	N/A	DWS Provided?	N/A
N/A	Landing Width (in)	N/A	N/A	DWS Contrast?	N/A
N/A	Landing Slope (%)	N/A	N/A	DWS Length (in)	N/A
N/A	Landing X Slope (%)	N/A	N/A	DWS Full Width?	N/A
N/A	Landing Curb? (Y/N)	N/A	N/A	DWS Offset (in)	N/A
N/A	Shared Landing?	N/A			
N/A	Gutter Ponding?	N/A	N/A	Gutter Slope (%)	N/A
N/A	Gutter Lip Ht (in)	1.0	N/A	Gutter X Slope (%)	N/A
N/A	Painted X Walk1?	No	N/A	Painted X Walk2?	No
	X Walk 1 Direction	To E		X Walk 2 Direction	To NW
N/A	X Walk 1 Width (in)	N/A	N/A	X Walk 2 Width (in)	N/A
	X Walk 1 Slope (%)	3.2		X Walk 2 Slope (%)	9.4
	X Walk 1 X Slope (%)	3.6		X Walk 2 X Slope (%)	2.3

N/A	Ramp inside XWalk1?	N/A	N/A	Ramp inside XWalk2?	N/A
	Road Slope (%)	6.3	N/A	Clear Space?	N/A
	Road X Slope (%)	2.4	N/A	Clear Space to XWalk (in)	N/A
N/A	Any Obstructions?	N/A	N/A	Storm Grate/Utility Hazard?	N/A
	Obstruction Type			Storm Grate/Utility Type	
		N/A			N/A
			Yes	Surface Condition? (G/P)	Good

Remove & Replace Curb Ramp With Two New Directional Ramps or Equivalent.
