Access Compliance Report

Public Rights-of-Way

(Curb Ramps)

Intersection ID: 53972	Main Street: SHOPTON_RD_WEST	Cross Street: CADEN_RD	Location: NW
ADA ID: 32B4942BCEA5	Ramp Type: PerpDiag	Initial Pass/Fail: Fail	Overall Compliance: No
		Severity Score: 22.5

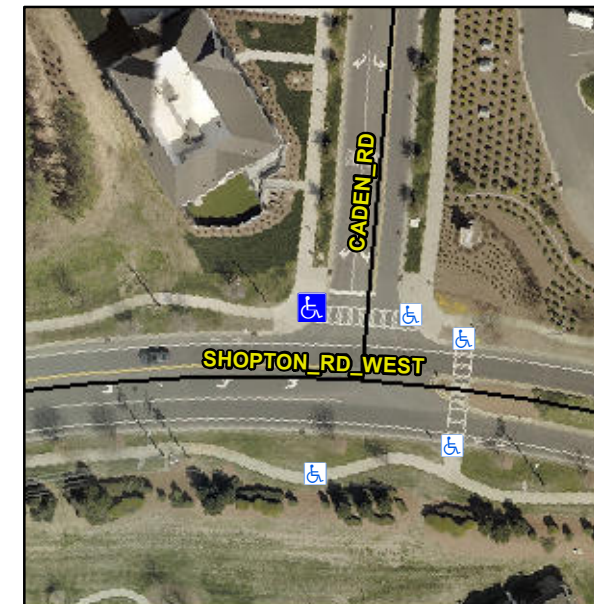
Not Found, R304.5.1, R304.2.2, R304.5.3

Compliance	Description	Data	Compliance	Description	Data
N/A	Ramp Length (in)	95.0	No	Ramp Slope (%)	8.4
No	Ramp Width (in)	43.5	No	Ramp XSlope (%)	3.8
N/A	Flare Type LT	N/A	N/A	Flare Type RT	N/A
N/A	Flare Slope LT (%)	N/A	N/A	Flare Slope RT (%)	N/A
N/A	Flare Traversable LT?	N/A	N/A	Flare Traversable RT?	N/A
N/A	Landing Length (in)	N/A	N/A	DWS Provided?	N/A
N/A	Landing Width (in)	N/A	N/A	DWS Contrast?	N/A
N/A	Landing Slope (%)	N/A	N/A	DWS Length (in)	N/A
N/A	Landing X Slope (%)	N/A	N/A	DWS Full Width?	N/A
N/A	Landing Curb? (Y/N)	N/A	N/A	DWS Offset (in)	N/A
N/A	Shared Landing?	N/A			
N/A	Gutter Ponding?	N/A	N/A	Gutter Slope (%)	N/A
N/A	Gutter Lip Ht (in)	N/A	N/A	Gutter X Slope (%)	N/A
N/A	Painted X Walk1?	No	N/A	Painted X Walk2?	Yes
	X Walk 1 Direction	To SW		X Walk 2 Direction	To SE
N/A	X Walk 1 Width (in)	N/A	N/A	X Walk 2 Width (in)	95.0
	X Walk 1 Slope (%)	0.4		X Walk 2 Slope (%)	0.1
	X Walk 1 X Slope (%)	2.5		X Walk 2 X Slope (%)	3.5

N/A	Ramp inside XWalk1?	N/A	N/A	Ramp inside XWalk2?	Yes
	Road Slope (%)	3.9	N/A	Clear Space?	N/A
	Road X Slope (%)	3.0	N/A	Clear Space to XWalk (in)	N/A
N/A	Any Obstructions?	N/A	N/A	Storm Grate/Utility Hazard?	N/A
	Obstruction Type			Storm Grate/Utility Type	
		N/A			N/A
			Yes	Surface Condition? (G/P)	Good

Remove & Replace Curb Ramp With Two New Directional Ramps or Equivalent.
